The Locomotive

THE HARTFORD STEAM BOILER
INSPECTION AND INSURANCE CO.

VOL. XXXIII.

INDEX TO VOL. XXXIII.—1920-1921

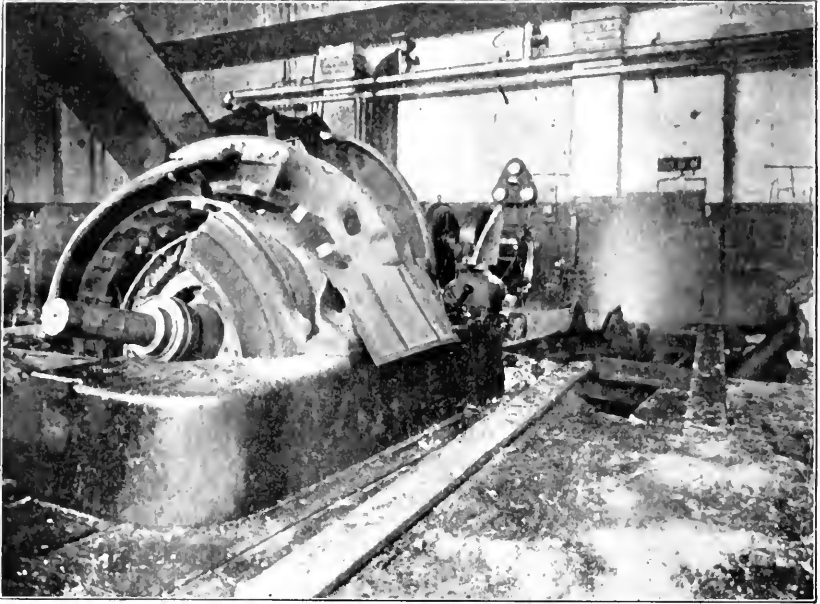
FIG. 1. VIEW OF GENERATOR

Explosion of a Large Steam Turbine.

THE accompanying illustrations are of parts of the wreck of a 3,000 K. W. turbo generator at the plant of the Connecticut Light & Power Company, Waterbury, Connecticut. This machine was destroyed by an accident which occurred on November 19, 1919, in which, most unfortunately, two men were killed and nine others more or less severely injured. The cause of the accident has not yet been definitely determined, we believe, but that it was of a violence and suddenness characteristic of an explosion is evidenced by the complete disruption of the machine, as our illustrations show.

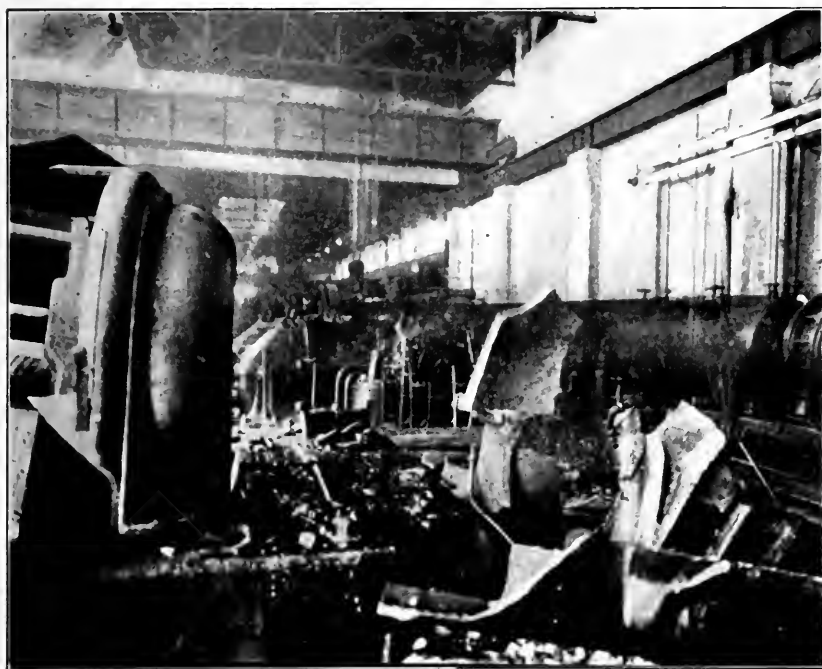
FIG. 2. TURBINE END OF WRECKED MACHINE

The wreck of the turbine itself was so complete and its remains consist in the main of such small fragments that from them it was impossible to determine at the examination made by a representative of our company what part failed first. The frame of the generator and its bearing pedestals were broken up and even the bed plate was

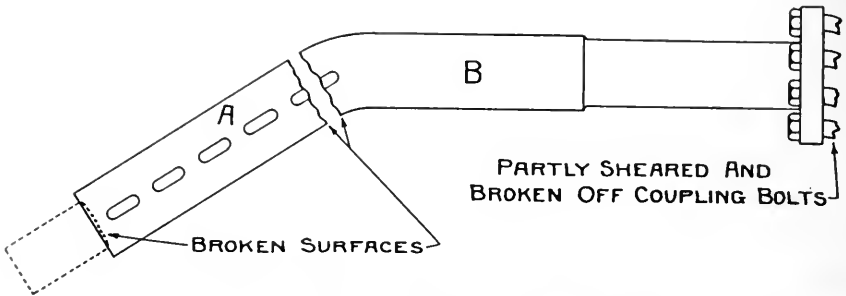
FIG. 3. SKETCH OF BROKEN TURBINE SHAFT

not spared. A peculiar and perhaps significant relic of the machine is the turbine shaft. This shaft was approximately 13" in diameter. It was broken in two places and the bolts of the flange coupling between the turbine and generator had partly sheared and broken off. One piece of this shaft, about 4 ft. in length, marked "A" in Fig. 3, after an extensive air flight, lodged in the basement under the turbine. Another piece, 8 ft. long, with the flange coupling, was hurled through a window into the yard. This latter piece, shown at "B" in Fig. 2, has a considerable offset, doubtless received an instant before the shorter piece of shaft was broken off. From the appearance of the bore of the turbine discs, all of which were considerably enlarged and belled out and from the fact that the piece of shaft on which they had been mounted was found after the wreck at some distance from the discs, there is reason to believe that the discs had slid off the shaft and started on their journey through roof and wall before the pieces of shaft commenced their respective flights. Of course, the blading in the turbine was broken up into small pieces. The rim of one of the discs, in which the blading was fitted, was completely ripped off.

Perhaps it was the character of the breaks in the turbine shaft in addition to other evidence against the over-speed theory which led the engineer of the Public Service Commission to the conclusion that the machine did not destroy itself by running away. As has been said, in such a complete break-up of all parts, as in this accident, one cannot determine where an initial failure occurred. The breaking of the very heavy shaft in two parts may, however, be significant and indicate that it first failed perhaps at the shouldered end shown in dotted lines in figure 3. If so, the portion of the shaft on which the discs were mounted would have had then one unsupported end and

with the combined weight of the discs under such circumstances would have commenced to sag or bend. Only a slight amount of sagging or bending of the shaft would have caused the discs to rub and the blading to break up and at the great velocity at which it was running, the shaft, out of center at its free end, would begin to whip around with increasing radius until it took the sharp bend and broke off through the keyways of the innermost disc as shown in our diagram. In such a theory of the accident, the next step would have been the breaking of the inner turbine bearing and a repetition of the whipping around of the remaining piece of shaft until the coupling bolts gave way. Of course in any such theory of the accident there still remains to be explained the cause of the original break of the shaft at the point shown in the dotted lines of figure 3. It is difficult to attribute such failure to any shock received by a sudden release of load or from any other condition which the circumstances of the accident can supply. It perhaps seems to dodge the issue to suggest that fatigue of metal was the ultimate cause of the catastrophe, but if it is certain that over-speed did not occur, no other explanation seems possible. The machine had been in operation for several years during which, undoubtedly, it had carried its loads and over-loads without mishap and had been subject to and had successfully withstood the usual strains and shocks of public service operation. That after such service it was unable to bear the not very severe shock of a relief of load can only suggest that it had been weakened by the strains of those many years service.

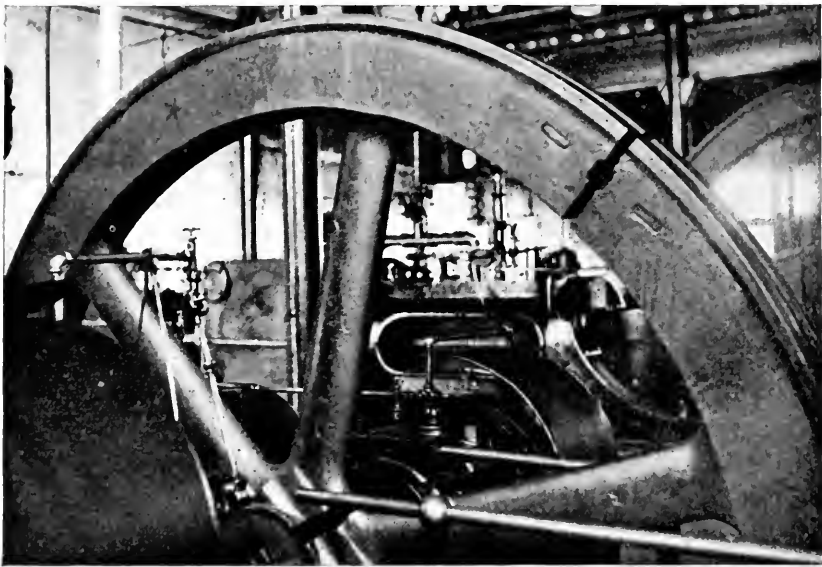
FIG. 1

These links, which are round and of steel, are inside of the rim, a suitable recess being left in the rim to receive them, and they are secured to the rim sections by means of cotter keys. The only visible parts of the rim joint, therefore, after the wheel is assembled, are the ends of the cotter keys. They can be distinctly seen in the illustration, as can also the separation of the rim at the joint due to the stretch of the links.

The cause of this accident has been attributed to derangement of the speed governor.

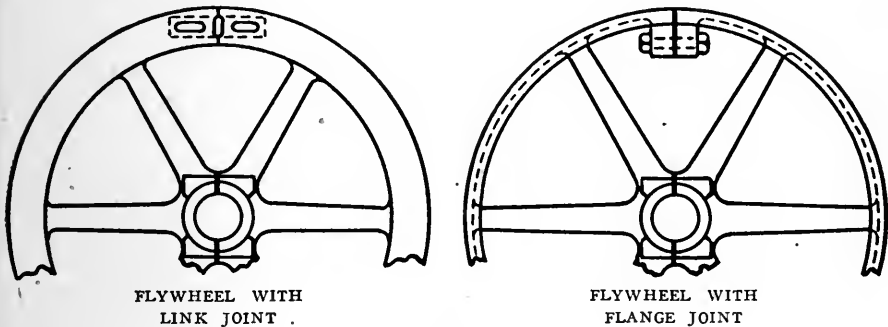
FIG. 2

When the links commenced to stretch, such a severe strain was transmitted through the arms to the hub-bolts that two of them broke off and one section of the hub itself split in two, while one arm was completely broken free from the rest of the wheel.

beyond some major fractures of the hub and arms of the wheel. The only usable picture we were able to secure of the wrecked flywheel does not clearly show that it was a complete loss. Such, however, was the case. The wheel in question was nine feet in diameter and was used in connection with a refrigerating engine. By the lucky coincidence that someone happened to be near the trottle and closed it at the moment the engine started to race, a complete disruption of the wheel was prevented. The wheel rim must have attained a considerable velocity as the links forming the rim-joints had stretched fully an inch due to the centrifugal force tending to separate the two halves of the wheel.

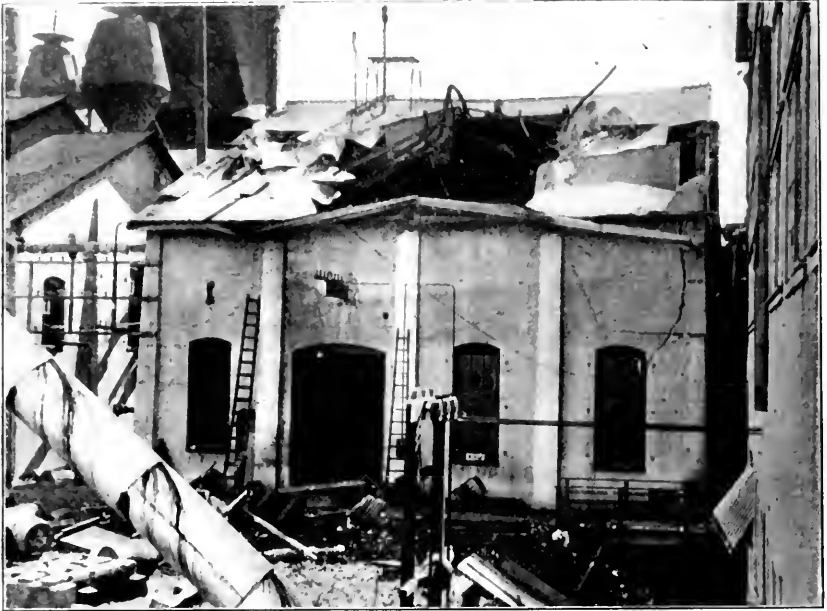
DAMAGE TO ENGINE HOUSE BUILT OF 12" CONCRETE WALLS.

The leading cause of the accident was a sudden release of all load from the engine by the breaking of the main driving belt which is thought to have been brought about by a piece of wood wedging between the belt and the face of the wheel. The broken main belt knocked off the governor-driving belt from its pulley so that the governor stopped revolving. If the trouble had terminated there the dire results shown in the illustrations should have been averted by the so-called safety cams on the valve gear which come into play when the governor drops to its lowest position and prevent the further admission of steam to the cylinders. However, as the big belt coiled up into the wheel pit, it broke the afore-mentioned governor rockershaft, which

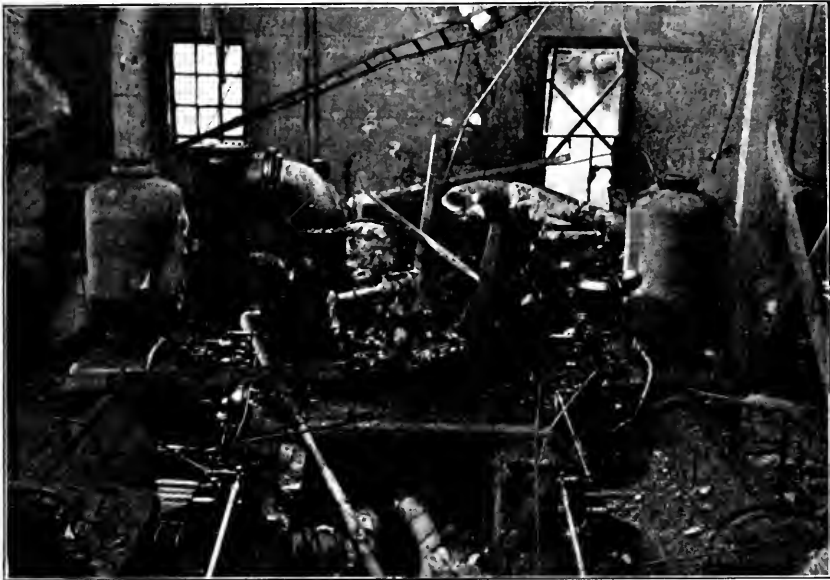
GENERAL VIEW OF CYLINDERS AND VALVE-GEAR.

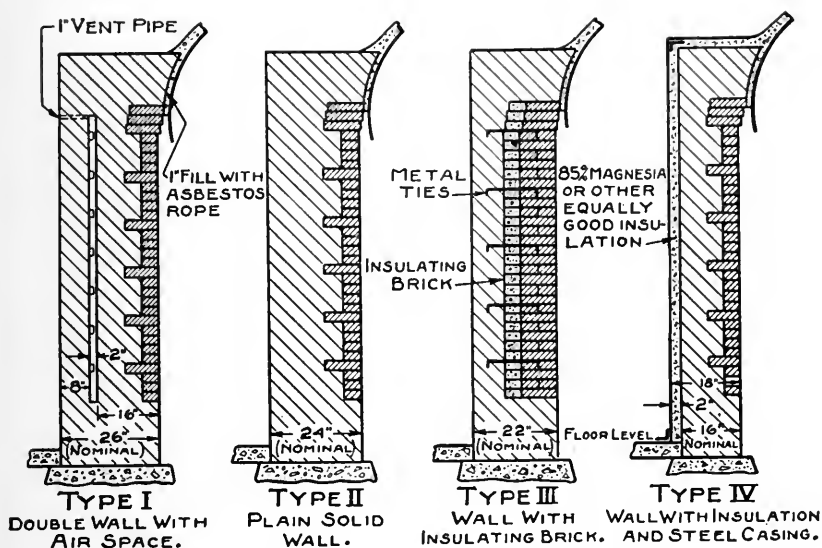
On our old setting plans the outside walls are shown as indicated by Type I, Figure A, but on the new plans we are showing all of the four types of construction described in Figure A, leaving it to the boiler owner to make his choice between these designs. Complete dimensions are given on the drawings for each type of construction.

FIG. A. DIFFERENT TYPES OF CONSTRUCTION FOR SETTING WALLS.

The sections in Figure A apply to the side walls at the rear of the bridge wall. For the furnace section in front of the bridge wall, we advise that the walls be battered from the grate level to the closing-in line near the middle of the boiler shell. Our drawings show a batter of six inches in this height, thus making the walls that much thicker at

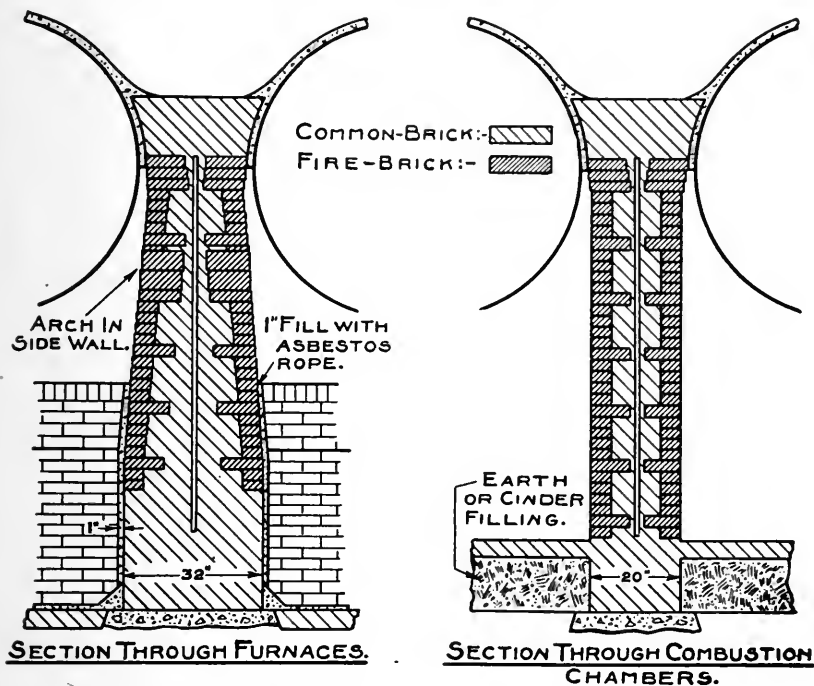
FIG. B. DIVISION WALLS BETWEEN BOILERS SET IN BATTERY.

In constructing side walls and division walls it is a good idea to build an arch in the firebrick lining at a height of about three feet

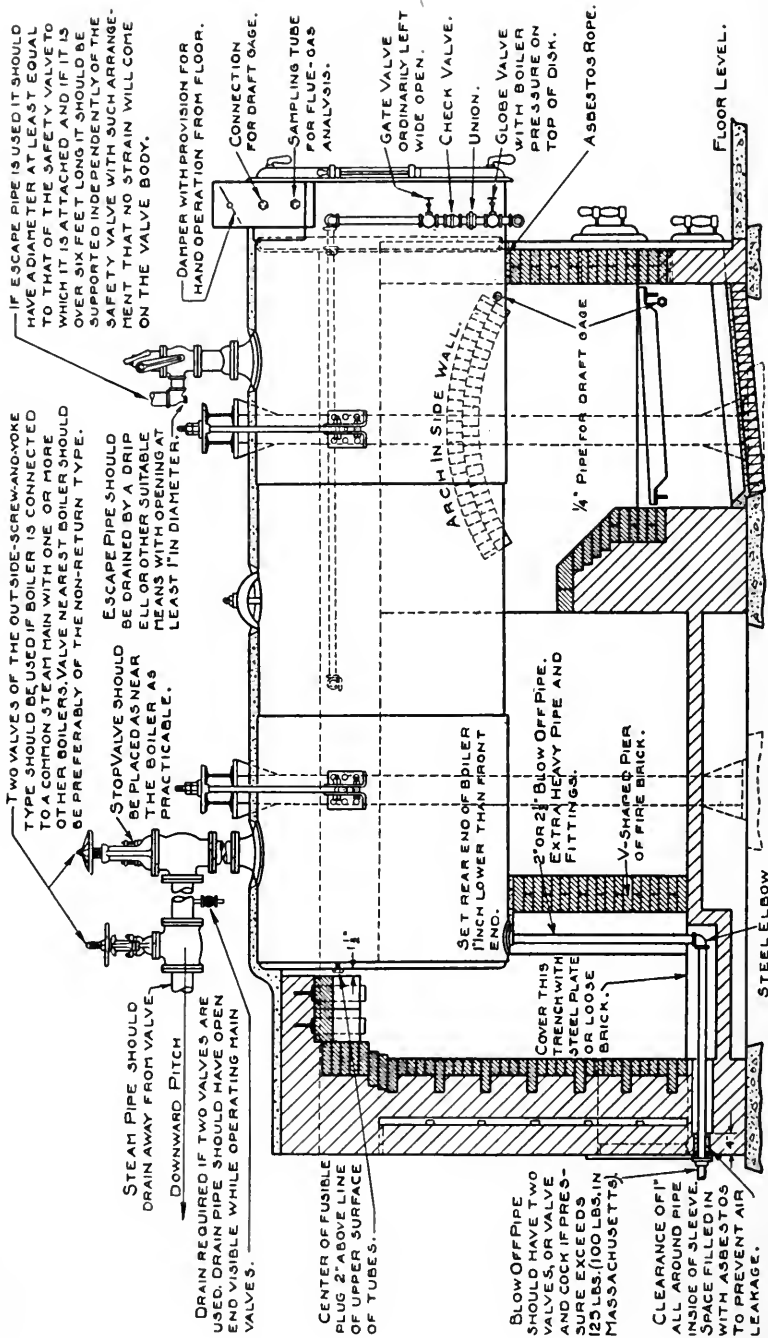
FIG. C. LONGITUDINAL SECTION THROUGH CENTER OF SETTING.

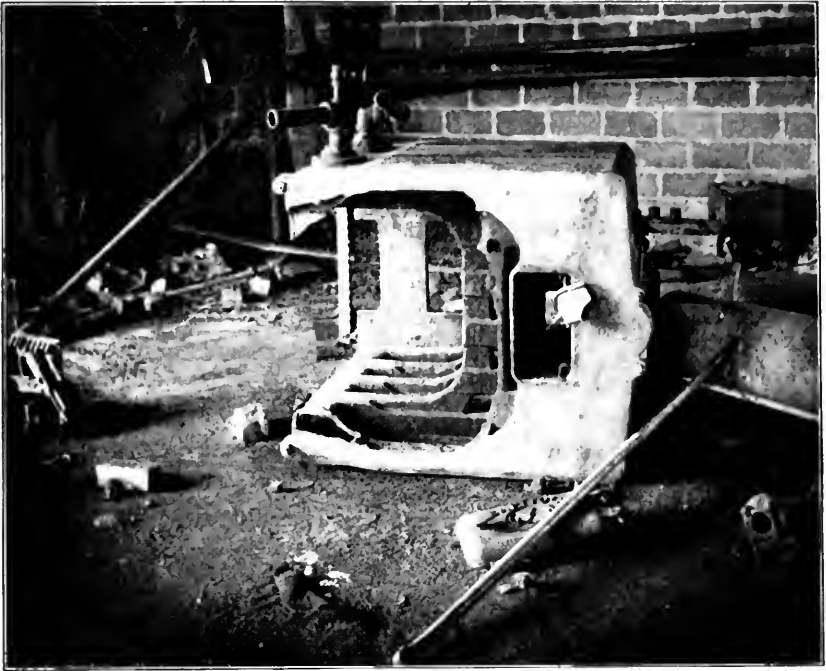
There are, to be sure, several features connected with such boilers that could be mentioned to controvert this statement, such as for example the much higher factor of safety of the structure of a low pressure boiler as compared with the usual factor of safety of power boilers. Also the fact that the low pressure boiler does not get so much of the forcing that the modern power boiler may be subject to. The explosion of a low pressure boiler, however, can usually be traced, not to lack of strength of its structure, but to ignorance and carelessness with the fitting up and the attendance. Over-pressures will occur in them in cases in spite of the most complete advice of the boiler manufacturer as to how they must be connected up and regarding the best way to operate them. During the heating season just passed, reports and news items reached us of a number of serious low pressure boiler accidents. One case in point is the explosion of the boiler shown in the accompanying illustration, which, from the information obtainable, seems to have been due to faulty fitting up and possibly also carelessness in handling. The boiler was used with a hot water system of heating in a garage. It was not provided with a pressure — or altitude gage and the installation was also possessed

EXPLODED HEATING BOILER.

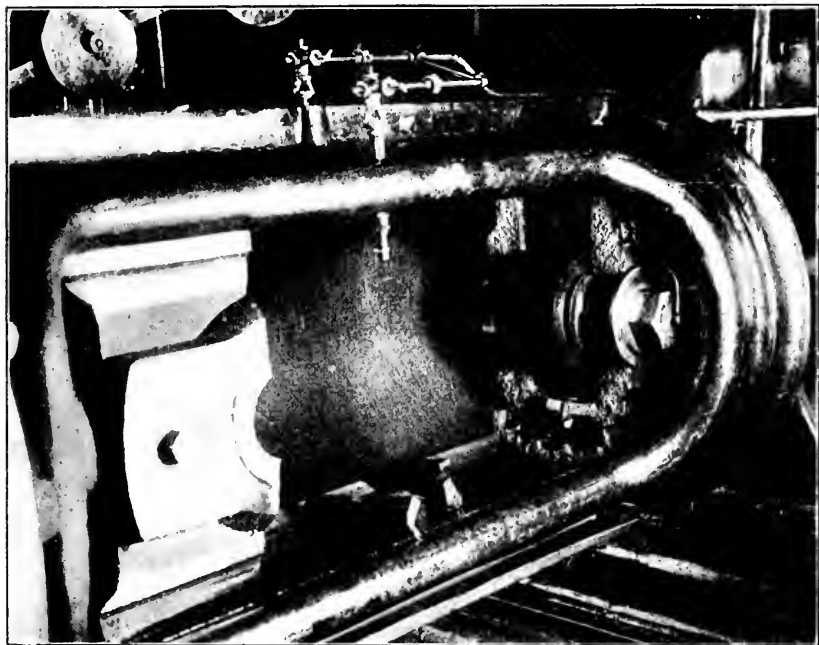
BROKEN CROSSHEAD ON AMMONIA COMPRESSOR.

the cross-head attached to it had carried the rod into the piston which caused the collar of metal to be rolled up. The force of these two actions, however, was not sufficient to bring the moving mass to rest so that, after the cylinder head blew out, the parts continued their

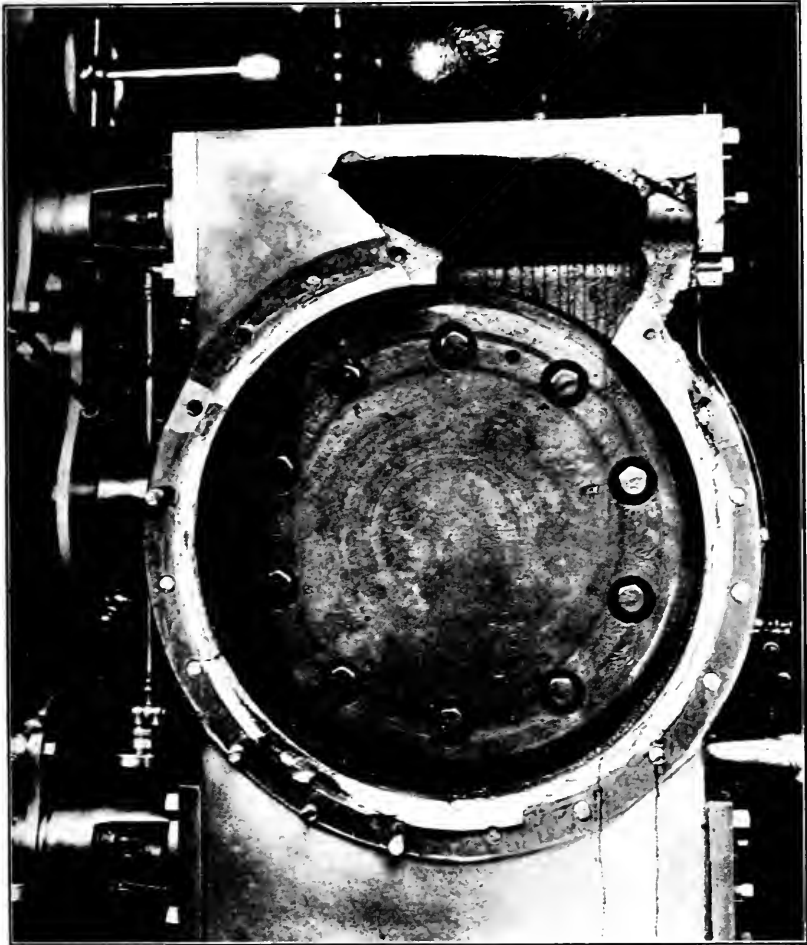
VIEW OF HEAD END OF CYLINDER.

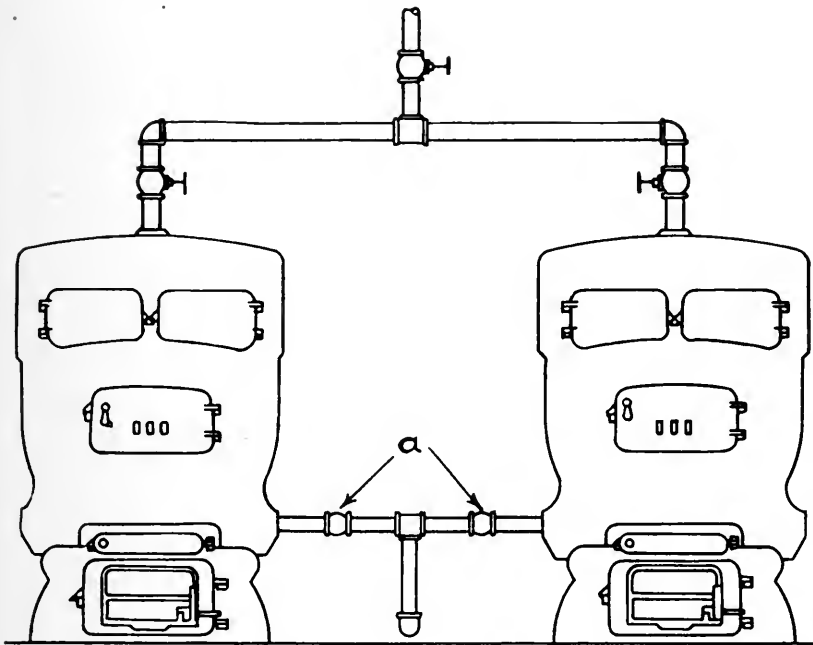
BOILER NO. 1.

BOILER NO. 2.

ical to some of the readers of this article that even a slight difference in pressure can exist in two boilers connected to a common steam main, but experience with low pressure boilers has shown this to be a fact, and the cause of this difference in pressure may be partly explained as follows:—

Within a low pressure steam system the balance of temperatures and pressures is a very delicate one due to several causes, such as local excessive friction of the fluid passing through the pipes and local

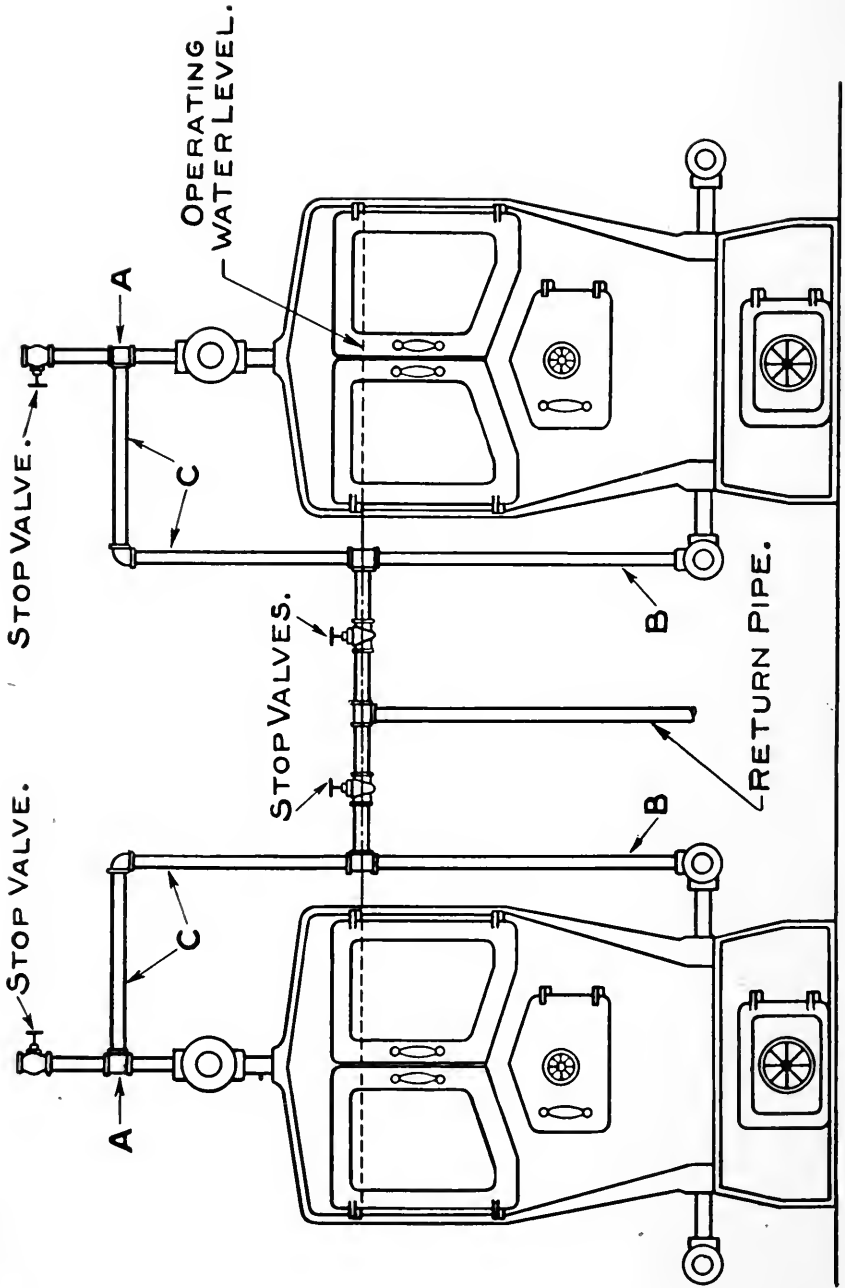
FIG. 2.

However, with the arrangement as shown, it becomes necessary to install a steam equalizing pipe (marked "c" in fig. 2.) to the highest part of the return pipe, and this equalizing pipe must be of ample size

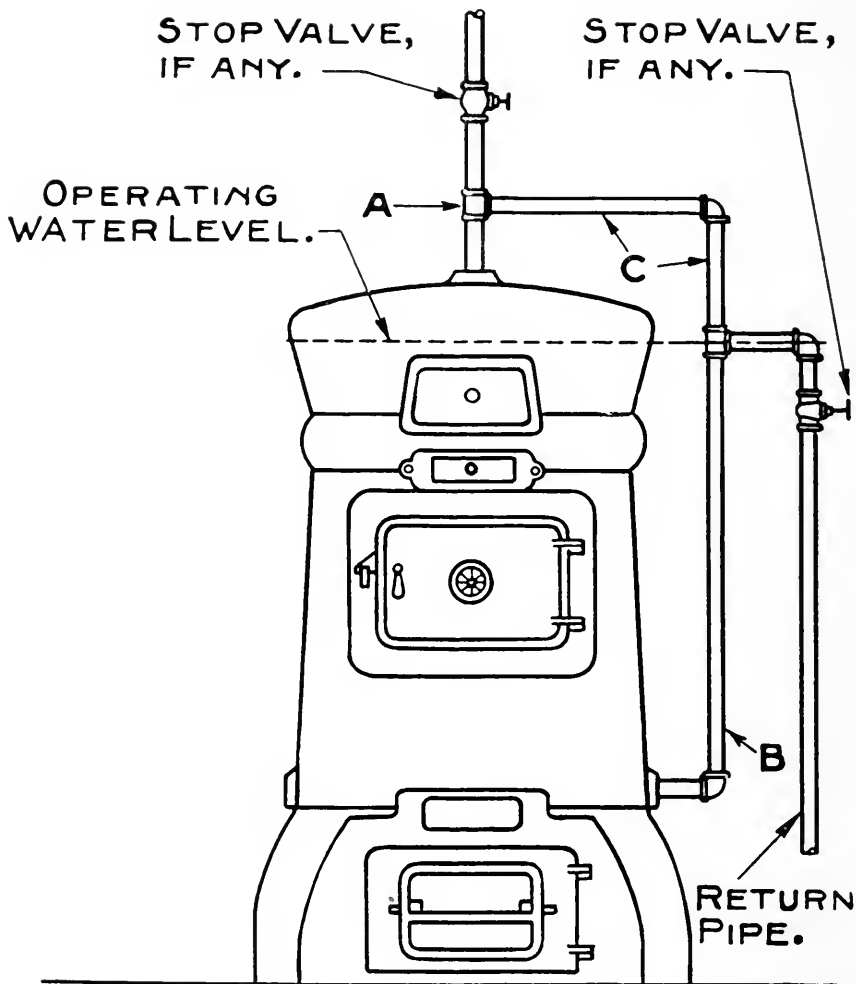
FIG. 3.

and with as few turns as possible in order to eliminate friction, but with such a pipe installed as shown water cannot be backed out of the boiler below the normal water level and the baneful effect of the installation of check-valves is thus done away with.

We now come to the main point of this article, the foregoing being all by way of introduction to a new scheme of attaching the return pipes to heating boilers, as announced in the title. This new method of piping the returns is shown in fig. 2. It will be noted that no check-valves are used. The returning water from the heating system is carried to a point at about the water level of the boiler although it actually enters the boiler at the usual location at the bottom. It would, of course, be possible to carry the water into the boiler directly at about the water level, but this is not desirable with the average cast iron heating boiler, for the reason that it may cause too great a temperature difference at this level in view of the fact that the returning water can be quite cold.

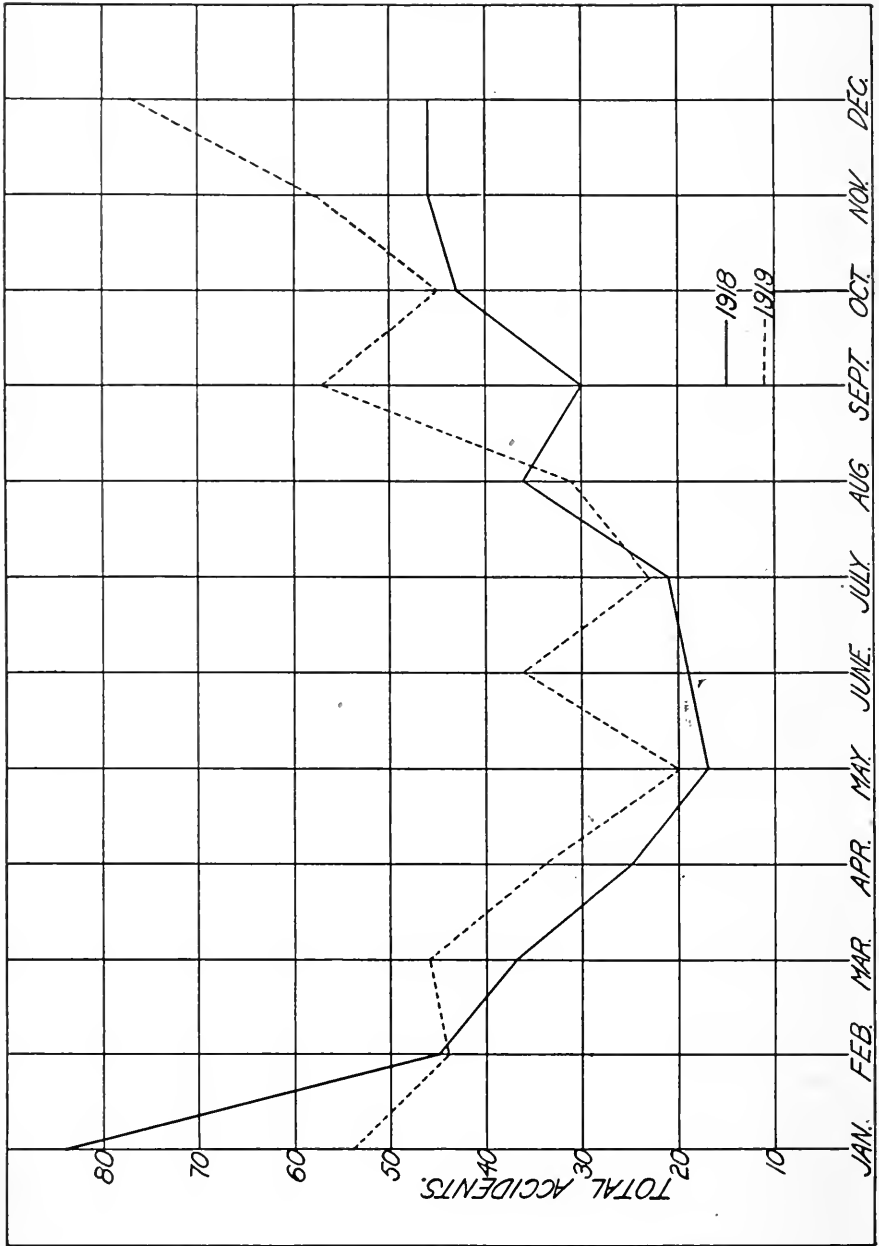
MONTH.	Number of Explosions.	Persons Killed.	Persons Injured.	Total of Killed and Injured.
January	84	18	63	81
February	45	12	48	60
March	37	8	29	37
April	25	11	19	30
May	17	7	15	22
June	19	13	19	32
July	21	11	29	40
August	36	16	17	33
September	30	19	29	48
October	43	8	34	42
November	46	4	9	13
December	46	3	29	32
Totals	449	130	340	470

CHART OF BOILER ACCIDENTS.

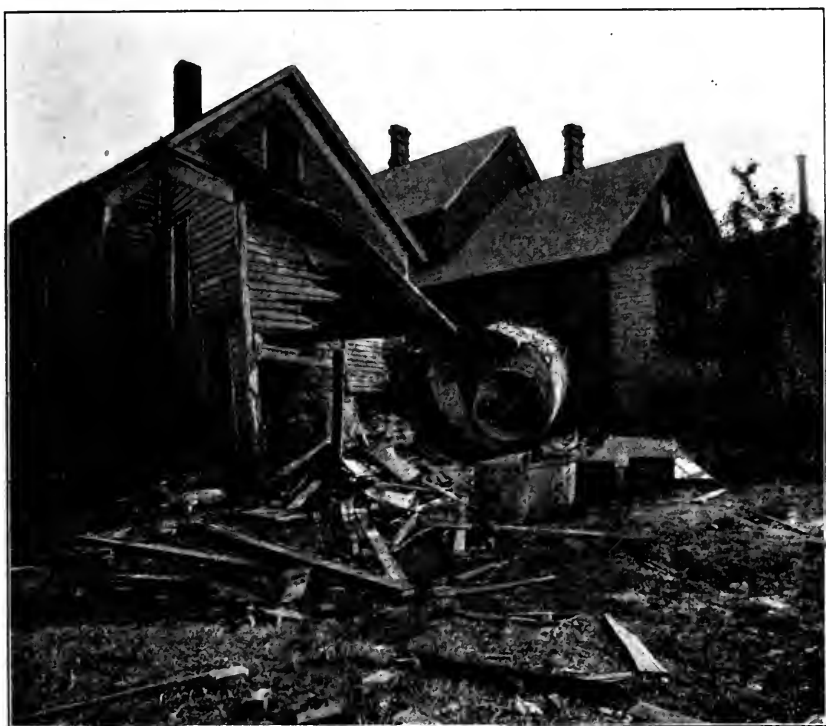
BOILER EXPLOSION AT OWOSSO, MICHIGAN.

from head to head. The rupture, which started from the center on top and continued to a point about four inches below the horizontal center line on each side, was partly by tearing of the plate and partly by shearing of the rivets. Only one joint of the furnace was affected

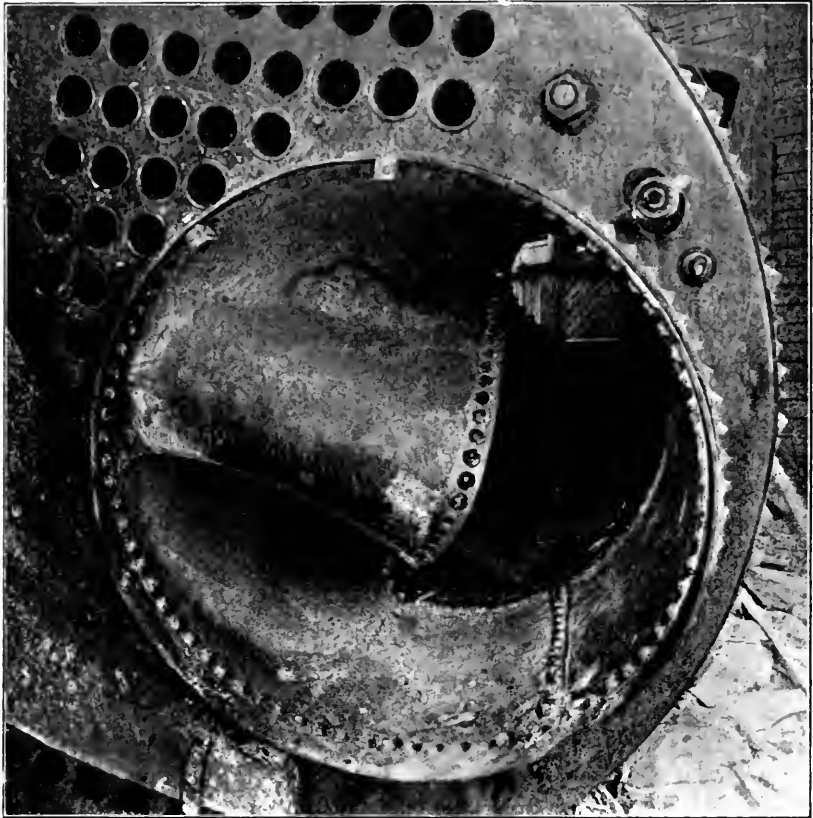
VIEW OF COLLAPSED FURNACE.

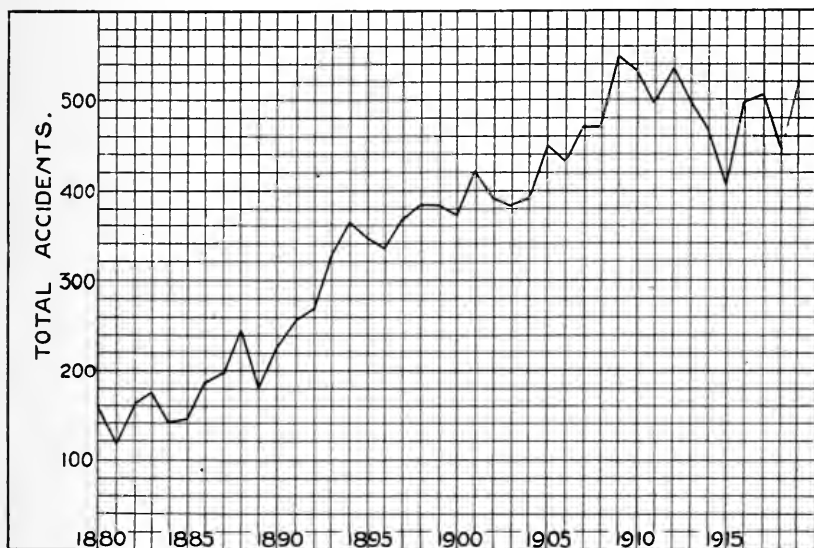
CHART NO. 1.—TOTAL EXPLOSIONS PER YEAR.

Chart No. 1 below gives the Total Explosions per Year from

the year 1880 to 1919 inclusive. Of course the "saw-teeth" are only natural in a chart of this kind. It is interesting to note, however, that

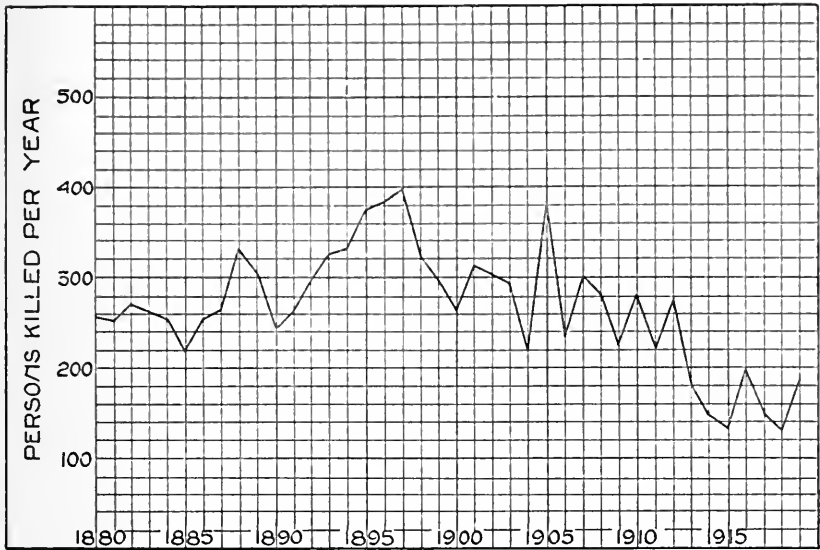
CHART No. 2. — PERSONS KILLED PER YEAR.

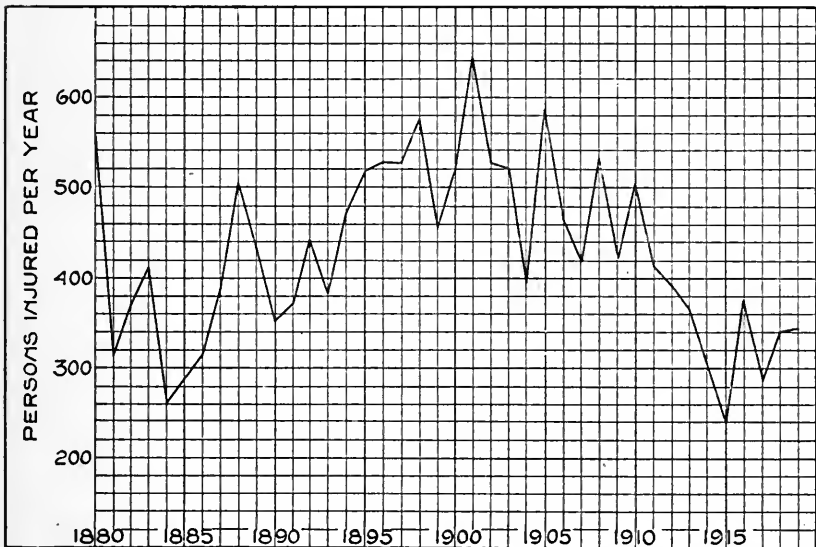
CHART No. 3. — PERSONS INJURED PER YEAR.

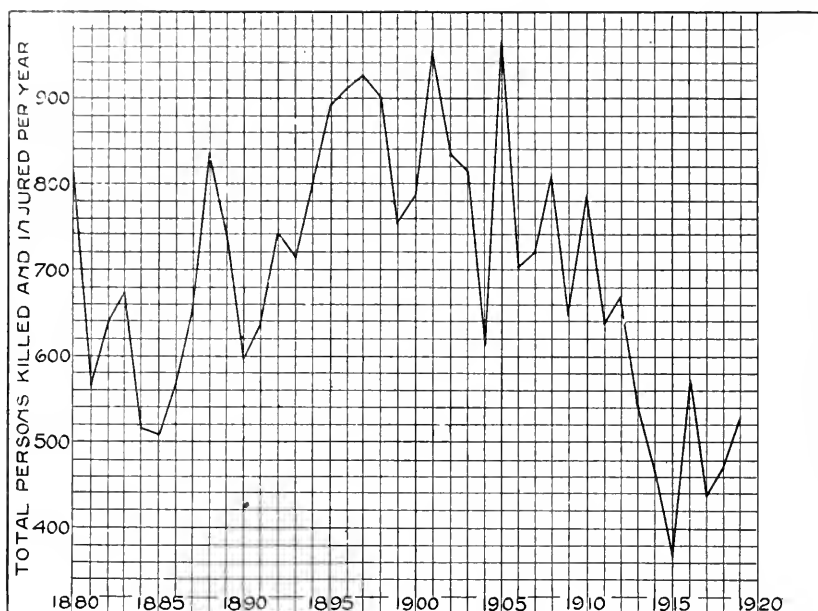
CHART No. 4.—TOTAL PERSONS KILLED AND INJURED PER YEAR.

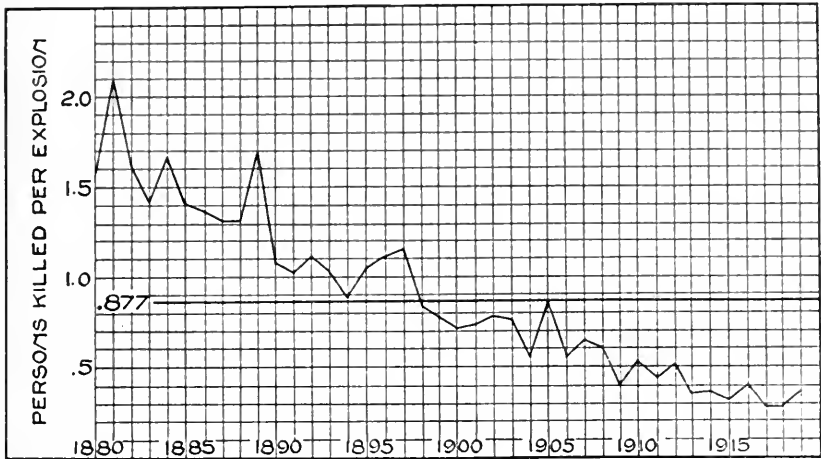
CHART No. 5. — PERSONS KILLED PER EXPLOSION.

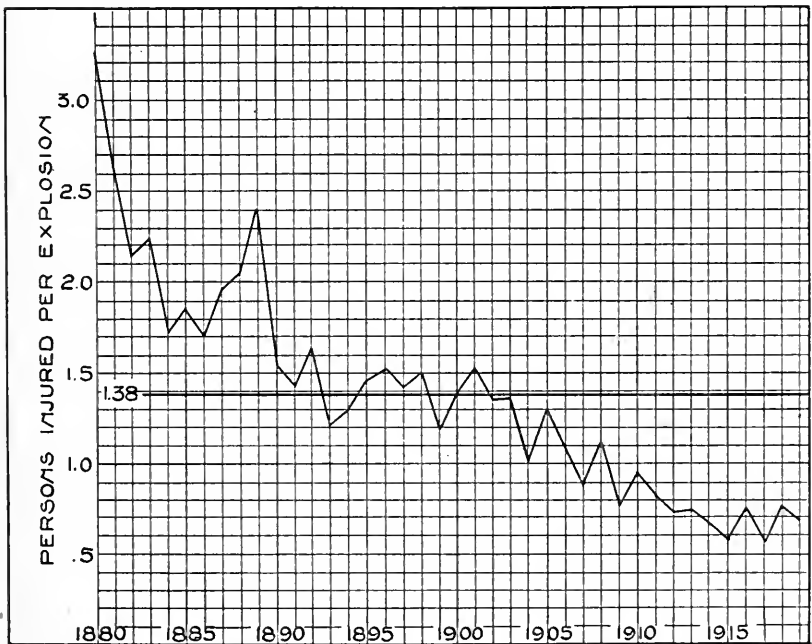
CHART No. 6. — PERSONS INJURED PER EXPLOSION.

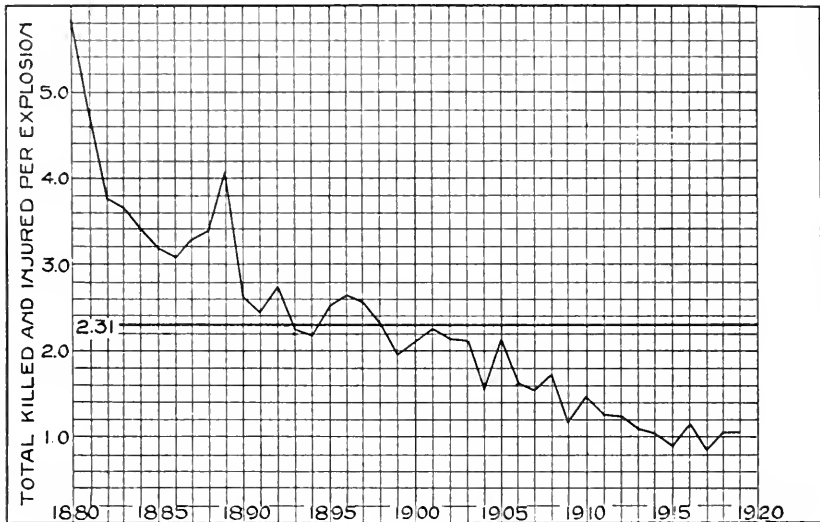
CHART No. 7. — TOTAL KILLED AND INJURED PER EXPLOSION.

average height in the past five years, in fact, is below that in the period from 1880 to 1885.

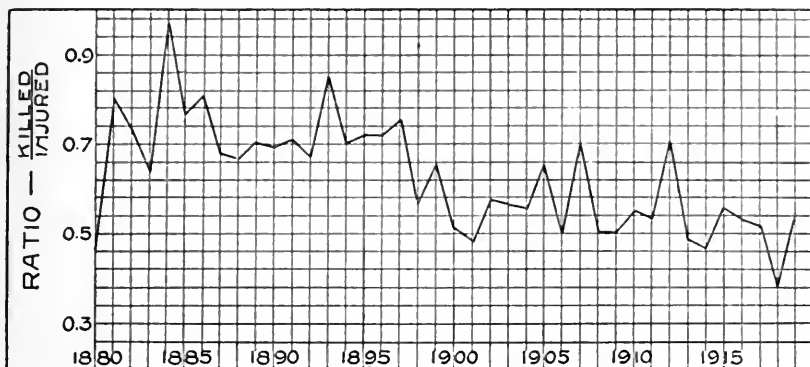
CHART No. 8. — RATIO $\frac{\text{KILLED}}{\text{INJURED}}$

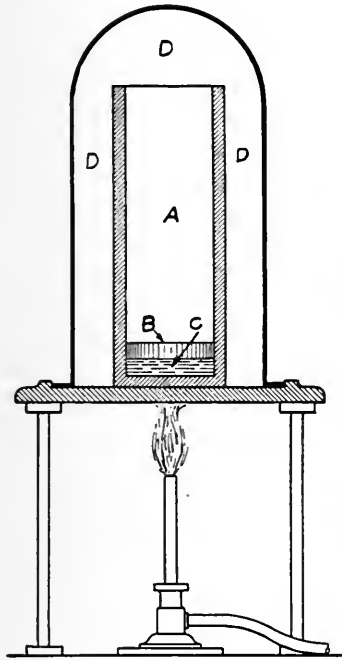
FIG. 1.

Let us suppose that we have an apparatus as shown in fig. 1 which consists of a cylinder A which has a piston B of an ideal nature such that it fits the cylinder perfectly and yet will move with absolutely no friction. Its weight is such that it will exert a pressure of 14.7 pounds on each square inch of the surface of the water C. We will suppose also that the water weighs exactly one pound. All the air has been exhausted from the surrounding space D so that the only pressure that can be exerted on the water will be 14.7 lbs. per square inch. By the nature of the arrangement the pressure will always be constant at 14.7 lbs. per square inch and cannot change as long as the piston is within the cylinder A. We will assume further that we have some means of supplying heat to the water as indicated in the sketch. If we start with the water at the temperature of 32° Fahrenheit and add heat to it the water will increase very slightly in volume but will still remain a liquid until the temperature of 212° is reached. At this point, if we continue to supply heat, the temperature will remain constant at 212° and the water will begin to change from a liquid to a vapor. It will continue to follow this change with a very rapid increase of volume at a constant temperature until the water is all vaporized. When and just when the vaporization is complete the volume occupied by the vapor will be 26.79 cubic feet.

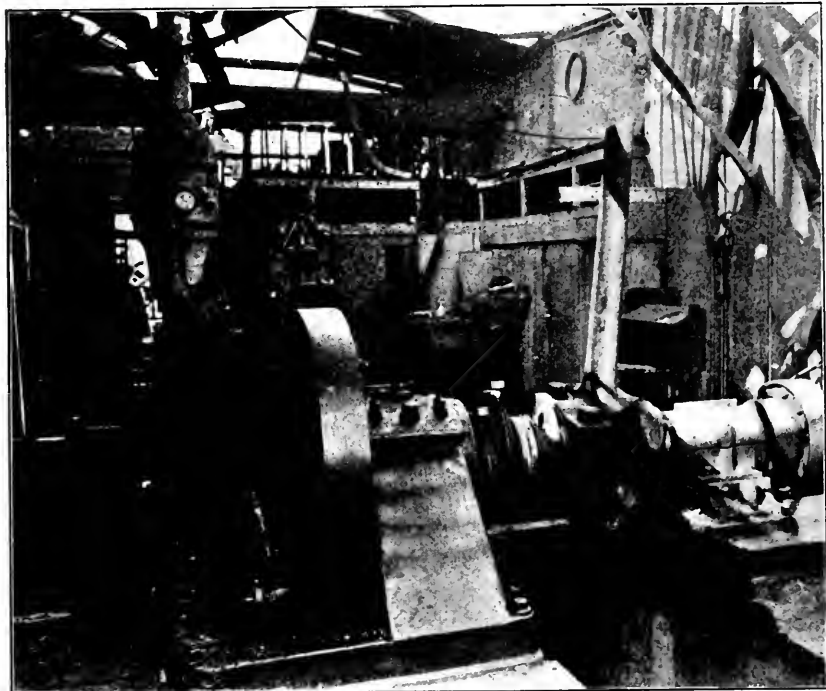
FLYWHEEL EXPLOSION AT STUTTGART, ARKANSAS.

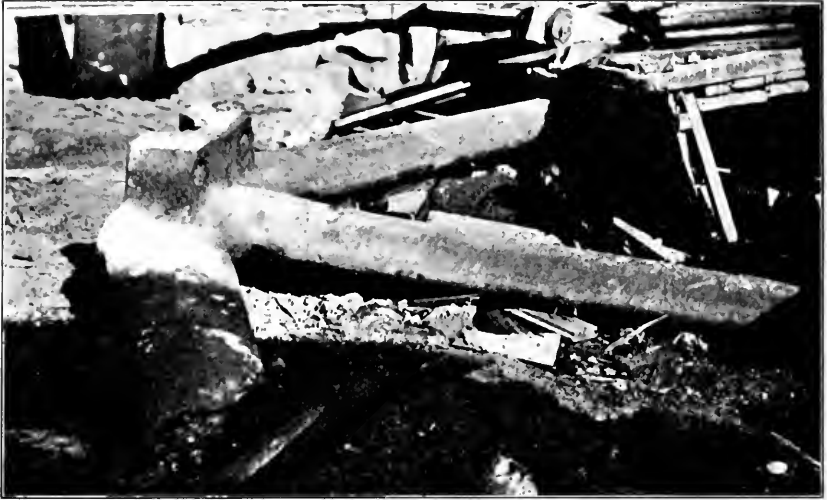
FLYWHEEL EXPLOSION AT LANCASTER, SOUTH CAROLINA.

Both of these engines were of the Corliss type and overspeeding resulted from breakage of parts of the valve gear. To clearly describe the causes of the accidents reference will be had to some sketches of the typical Corliss valve gear. Fig. 1 shows the

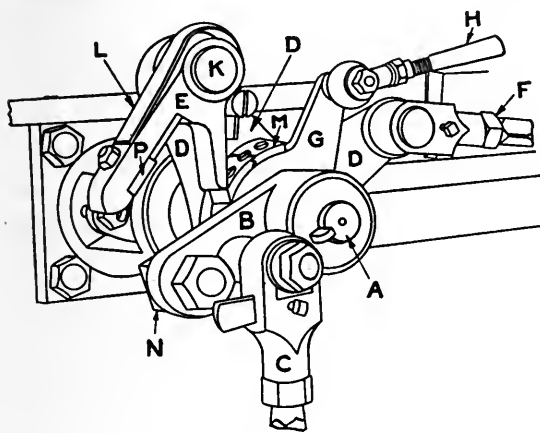
FIG. 1.

parts of this gear that are intimately related to and operate the steam admission valve for the head end of the cylinder. A similar arrangement is used at the crank end of the cylinder. In this sketch A is the end of the valve-stem, which passes through the other parts of the gear and into the cylinder where it is

attached to the cylindrical Corliss valve. The valve is actuated by the oscillation of this valve-stem. Part B is the steam-arm and, as will be seen, is secured to the valve-stem by a key. The rod C, attached to the steam-arm, is drawn down to the position shown in the sketch by a dash-pot on its lower end which is not illustrated here. In the position shown, the steam-valve is closed. The double-arm D is machined to a running fit on the valve-stem and has two arms — one extending to the left and carrying the steam-hook E and the other extending to the right and having attached to it the steam-valve-rod F. This steam-valve-rod is attached, through a series of levers, to the eccentric of the engine and is given a reciprocating motion which changes to an oscillating

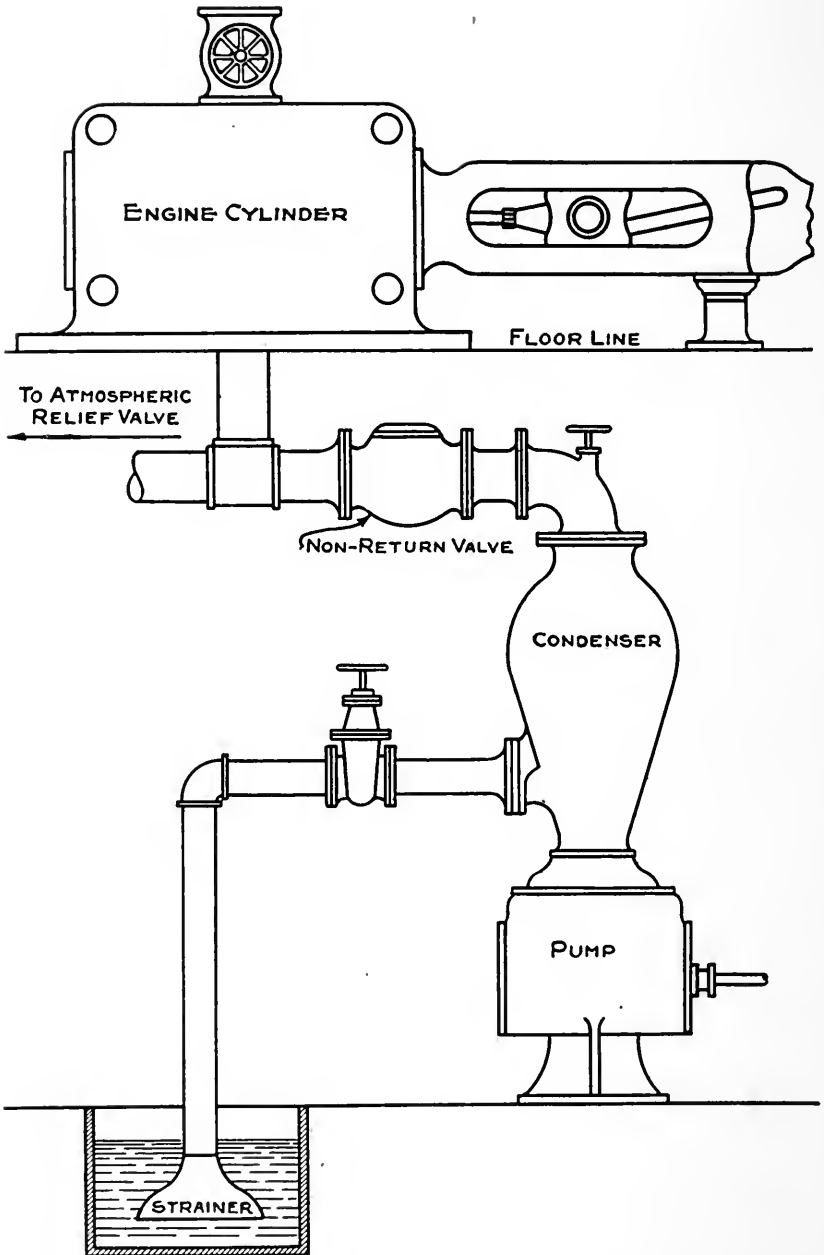
TYPICAL JET-CONDENSER INSTALLATION.

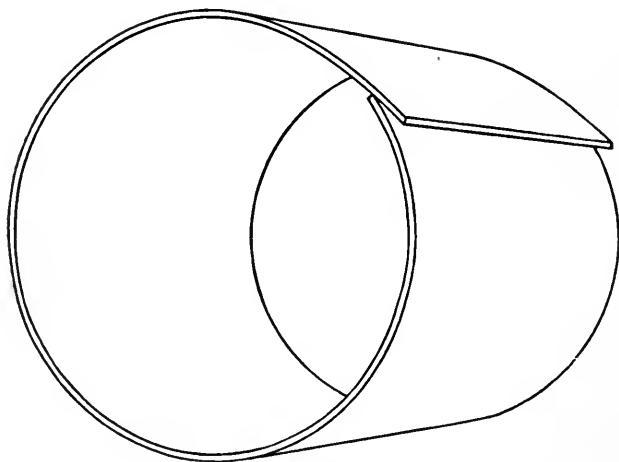
FIG. 1.

When a boiler plate is rolled to a cylindrical form, the edges of the plate, in passing through the rolls, are not gripped as effectively as is the middle of the plate so that the ends are left somewhat flat. The condition produced is illustrated in Fig. 1. This necessitates the plates being forced together at the edges and this produces an added stress that persists unless relieved

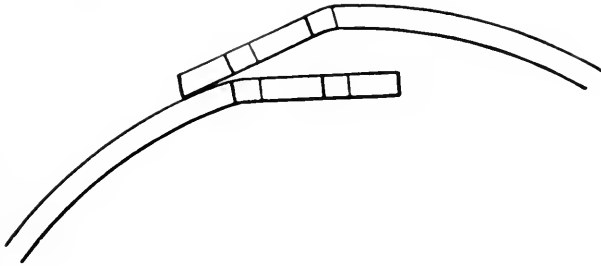
FIG. 2.

by annealing. In addition to this the plates, if bent after punching, will bend along a line of rivet holes as shown in Fig 2 in somewhat exaggerated form.
