The Locomotive

THE HARTFORD STEAM BOILER
INSPECTION AND INSURANCE CO.

VOL. XXXIII.

INDEX TO VOL. XXXIII.—1920-1921

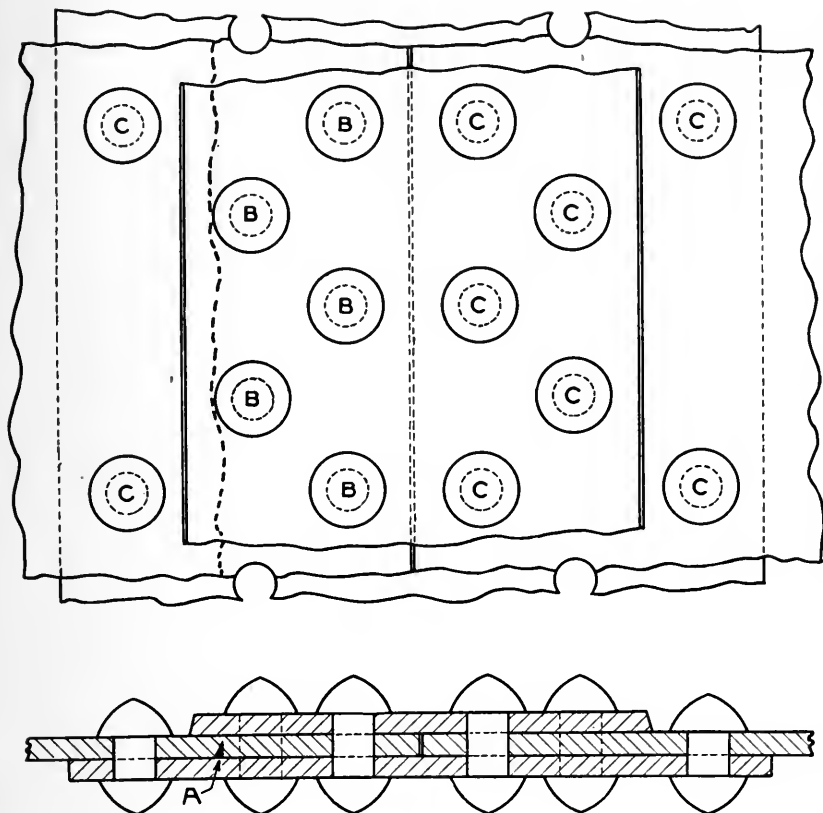
FIG. 5.

Assuming that a double riveted lap joint has been changed to a triple riveted butt construction, the joint, after placing the butt straps and riveting, would appear as shown in Fig. 5 on page 145 with the rivet holes of the original lap joint at B and the new holes at C. If a defect existed in the plate as shown at A the joint would be very faulty. Assuming the original joint as having the rivet holes spaced $3\frac{1}{4}$ inches and the additional holes spaced $6\frac{1}{2}$ inches, if the plate material were defective or contained a lap crack as shown, the failure of the joint would require only the shearing of the rivets in long pitch, or $6\frac{1}{2}$ inches, and the failure of the defective plate.

It might be argued that the exposure of the inside of the lap seam, when the change to a butt seam is made, would reveal the presence of a lap seam crack. A crack of this nature is, however, often present in a boiler of this construction after years of service although it may not be visible to the naked eye. But, even though no crack exists,

it must be remembered that boiler plate, like any other material, becomes fatigued after long years of service and for this reason, after it has been under stress for many years, it should not be subjected to a change of shape and torture of the material in an endeavor to keep the boiler in service, especially when there is evidence that the altered structure is defective.

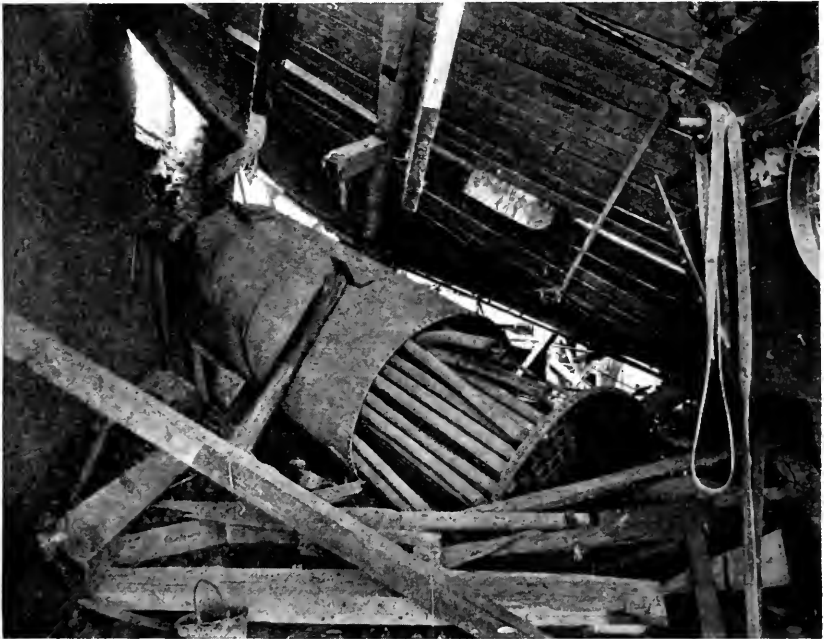
THE year 1920 closed in an unfortunate way for the firm of G. H. Tilton and Sons of Savannah, Georgia. About the middle of the afternoon of December 29th, while everything was running smoothly and the year's work was nearing its close, one of the boilers in the mill of this concern exploded with terrific violence and serious damage was done to the plant. A general view of the ruins appears on the front cover of this issue of *The Locomotive* and, as will be seen by reference to that picture, the wreckage was

VIEW OF EXPLODED BOILER.

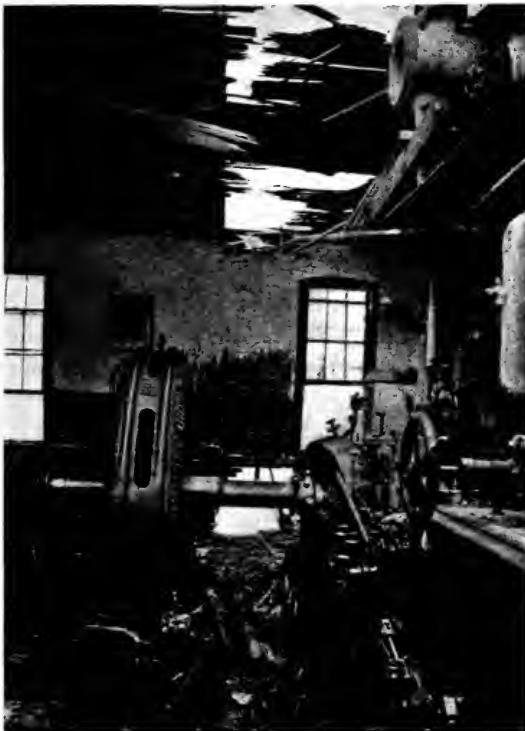
FLYWHEEL EXPLOSION.
KENTUCKY UTILITIES CO.

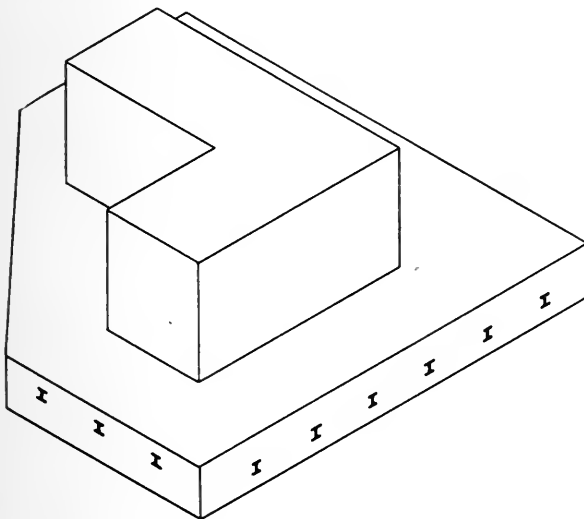
FIG. 1

the area necessary to support the weight will not be great enough to bring the bearing pressure on the soil within the safe limit without excavating to an extreme depth. In such cases it will be best to excavate to a moderate depth and then to construct a mat, or sub-foundation, as shown in Fig. 1,

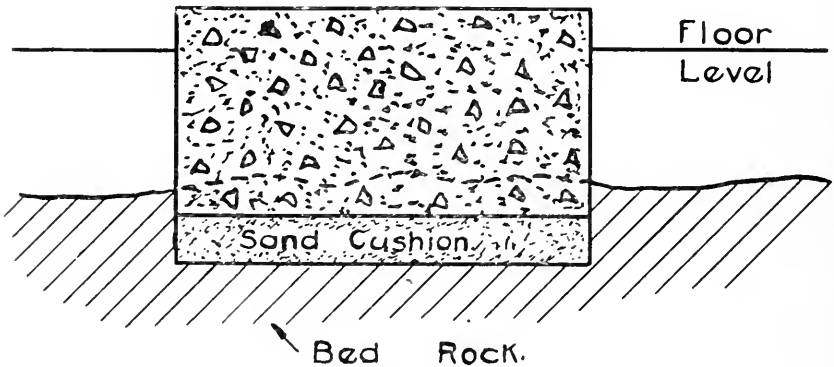
FIG. 2.

There have been installations in which the foundations of the walls of the buildings have been placed on bed rock and vibration has developed in the building when the machinery also had its foundations resting on this rock. In such cases, when the rock lies so near the surface that it is difficult to avoid placing the machinery foundations upon it, it is well to blast an opening in the rock so that a sand cushion may be placed between the engine foundation and the rock as illustrated in Fig. 2. A box or retaining wall of concrete as shown in Fig. 3, may also be used to accomplish this purpose. The necessary spread or area of foundation is, of course, based on the allowable bearing pressure on the rock.

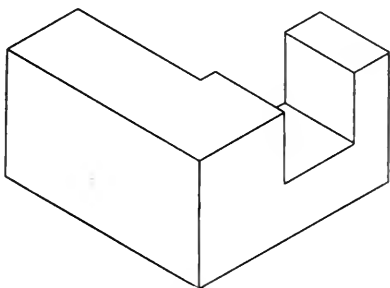
FIG. 4.

by the use of a mat or sub-foundation. The plan of the foundation follows, roughly, the outline of the base of the engine. When there is an outboard bearing the design should be somewhat as shown in Fig. 4 in which the foundation or pier under the outboard bearing is tied to the rest of the structure by a slab of concrete. With such a construction some thought should be given to the weight imposed upon the foundation by the outboard-bearing pedestal and the weight of the parts that such bearing carries. Even though the total area of the foundation may be sufficiently great to support the total weight without exceeding the safe bearing pressure, it is quite possible that the load may become highly concentrated at certain points such as that under the outboard bearing. In such a case it would be well to spread the base of the foundation under the pedestal by sloping the walls or by a sub-foundation to bring the pressure within the allowable limits.

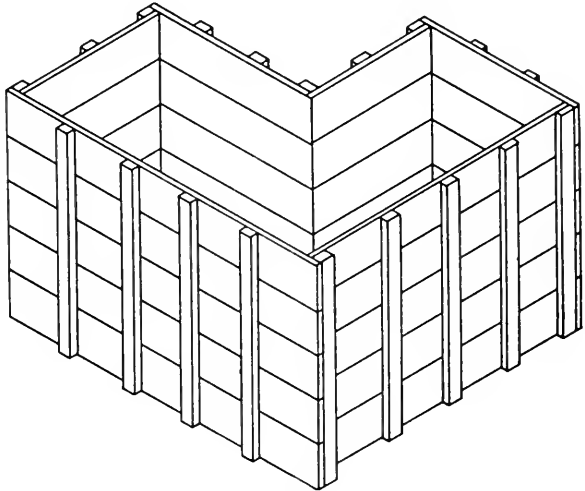
FIG. 6.

When the sides of the foundation form have been constructed they may be placed in position and fastened together as shown in Fig. 6. The sides should be made square with each other and then braced in that position with boards laid diagonally across and fastened to the top of the form. Lines should be run across the top of the form to indicate the center lines of the shaft and the cylinder, and the form

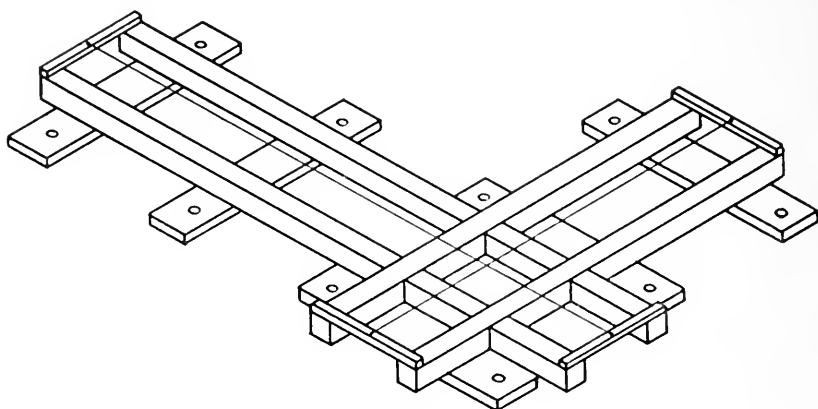
FIG. 7.

The next step is to support the holding-down or foundation bolts in the proper position in the foundation opening. To do this a template, such as that shown in Fig. 7, on page 170, is necessary. The center lines of the engine shaft and of the cylinder are carefully laid out at right angles to each other on the template and

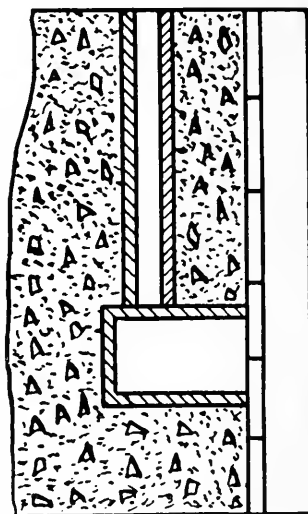
FIG. 9.

and for this purpose the foundation should be constructed with pockets to hold the lower washer and nut. The details of such a construction are shown in Fig. 9. When this plan is followed, the bolt holes may best be formed by boxes which are held in place by cross braces or stays at the top and by the form for the pockets at the bottom. This construction for the bolt holes is of great advantage when placing heavy machinery. There are no bolts to interfere with the moving of the machine and it can easily be rolled into position and the bolts dropped in later on. When the bolts are not removable a great amount of time is often lost by the necessity of elevating the machine above them and, furthermore, damage to them may very readily occur.

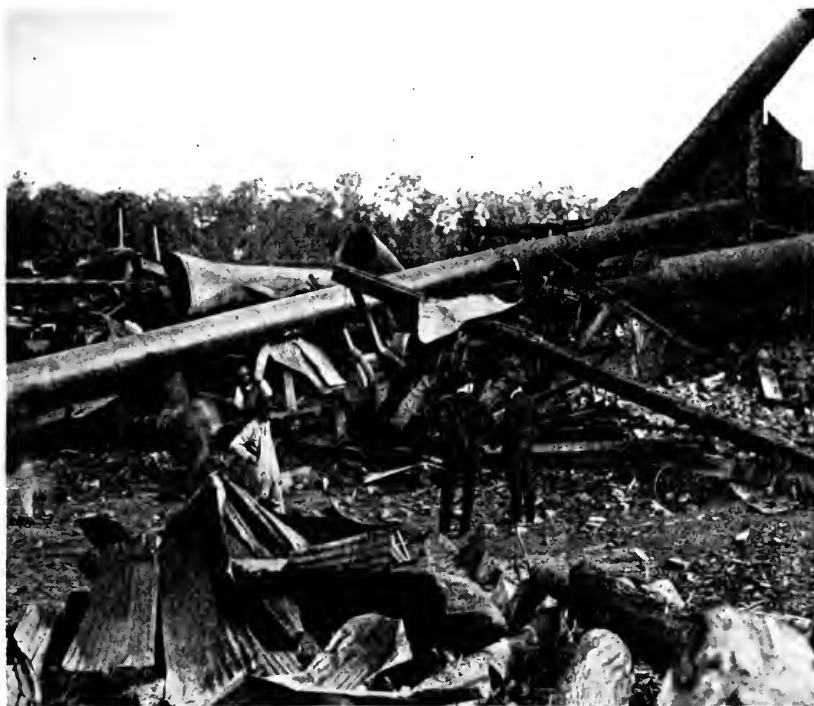
BOILER EXPLOSION AT LUMBER, SOUTH CAROLINA.

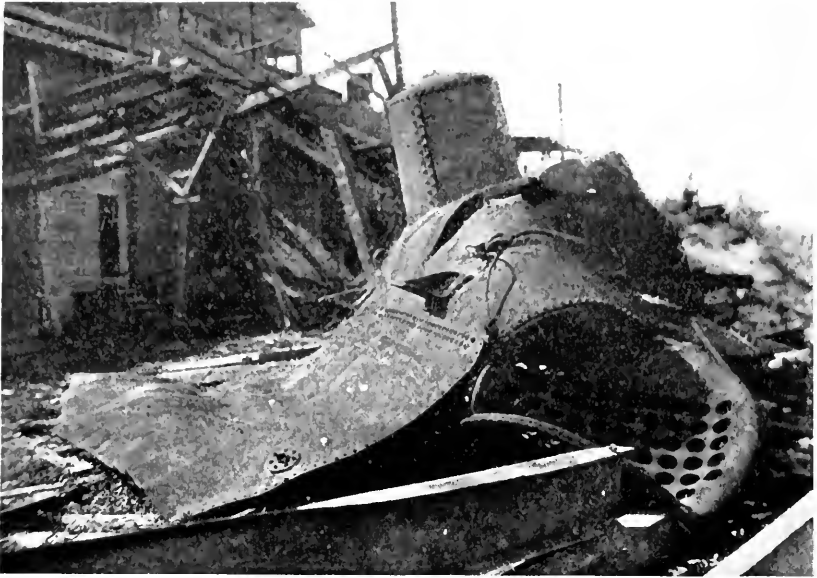
SHOWING HOW THE BOILER RIPPED OPEN.

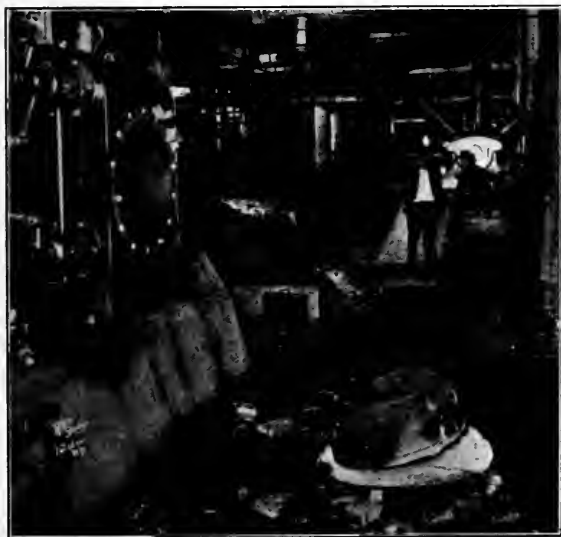
An attendant, who was standing nearby, shut off the steam from the engine as soon as it was possible for him to do so but not before further damage had been done. The connect-

THE CYLINDER HEAD END OF THE WRECK.

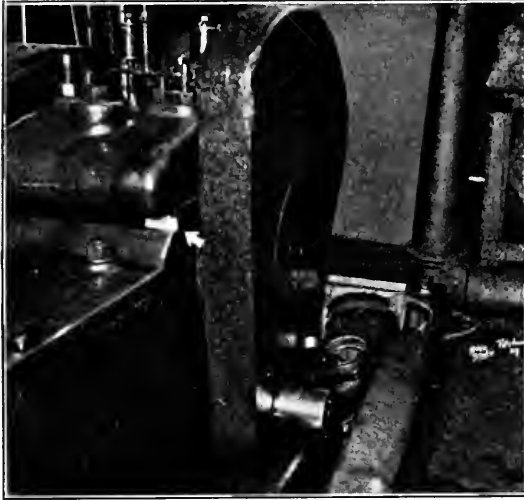
THE CRANK END OF THE WRECK.

lifted bodily from the inboard bearing when the crank-pin struck the connecting-rod. The parts came to rest at this point as illustrated herewith. It can be clearly seen how the bearing-cap was lifted from its place, the cap bolts having been elongated to permit this movement.

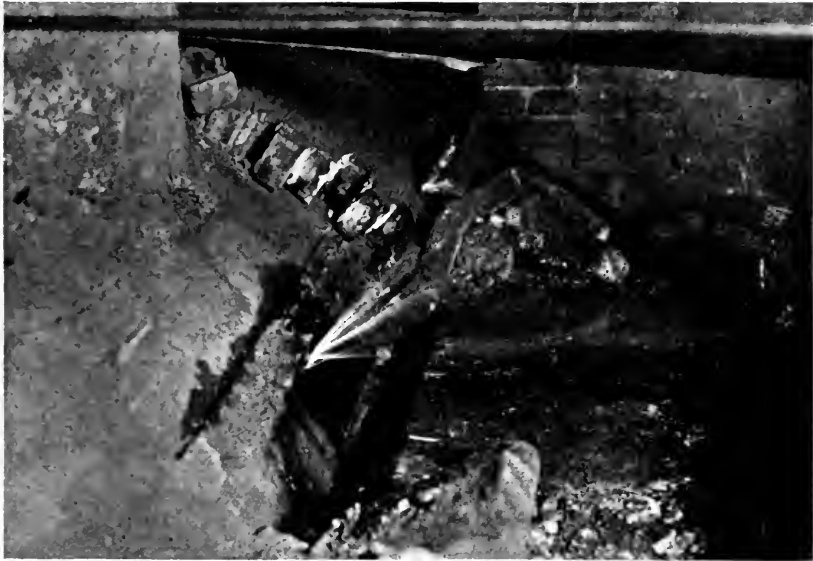
ceeded to learn, if possible, the source of the leak that had caused that stain on the boiler shell. The engineer called his attention to a water pipe running across and somewhat above the boiler, mentioning that considerable condensation collected on this pipe and that possibly there was some water reaching the boiler from this source. This did not seem an altogether satisfactory explanation, however, so the inspector ordered some of the asbestos covering of the boiler removed at a point where he believed a leak might be. The boiler was then filled with water under pressure and it was probably some-

WATER ISSUING FROM A LAP SEAM CRACK.

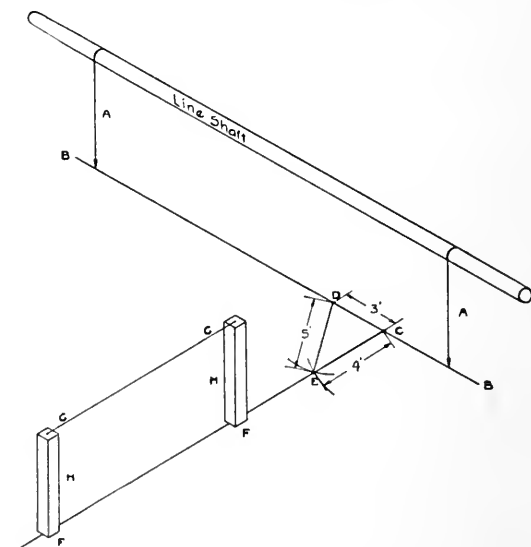
FIG. 1.

To secure this reference line the line shafting must be placed in alignment from hanger to hanger. The next step is to drop a plumb line from two points of the line shaft to the floor, as shown in Fig. 1 at AA, and thus get the line BB which will necessarily be parallel to the shaft. From a point C (the selection of which will later be made apparent) measure off the distance CD equal to three feet. Then with a board or steel tape, swing an arc with center at C and radius

of four feet and another with center at D and radius of five feet. The intersection of these two arcs will give the point E and the line through CE will be perpendicular to the line BB because the sum of the squares of the two short sides of a right angled triangle is equal to the square of the hypotenuse or long side.

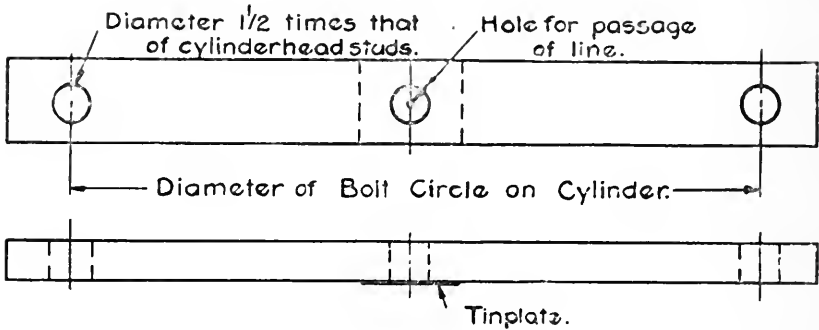
FIG. 3.

To locate and securely fix the line at the head end, a fixture

such as that shown in Fig. 3 may be used. For the crank end a wooden plug similar to that shown in Fig. 4 should be made. This plug should be turned and bored in the lathe so that the center of the small hole passing through it and the center of the plug itself will be identical. These two fixtures are installed on the cylinder as shown in Fig. 5. One end of the line is tied around a short stick or rod, as shown in Fig. 5, and is then passed from the head end of the cylinder through the hole in the tin plate, which should be no larger than to just permit passage of the line, through the hole in the plug at the stuffing box and continued several feet beyond the center of

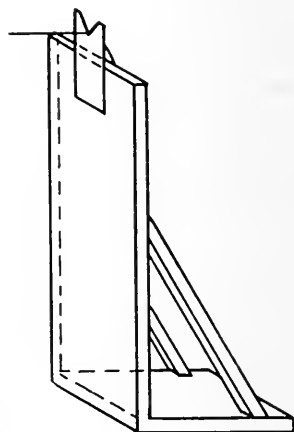
FIG. 7.

scheme may also be used at the cylinder end — is as illustrated in Fig. 7 on page 204. The notched piece of sheet metal is clamped to the post until its correct position is accurately determined and it is then securely fastened to the post. The line is run through this notch and fastened on the

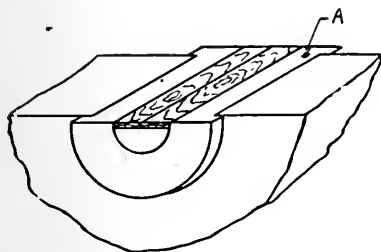
FIG. 8.

In this work the bearing caps are first removed and a piece of board is forced into the lower box of each bearing, as shown in Fig. 8. On this board a line is laid out, by careful measurement, to represent the center line of the bearing. A level line is then erected to intersect and to be at right angles to the center line of the cylinder. The bearings are then shifted so that their center lines lie exactly under and

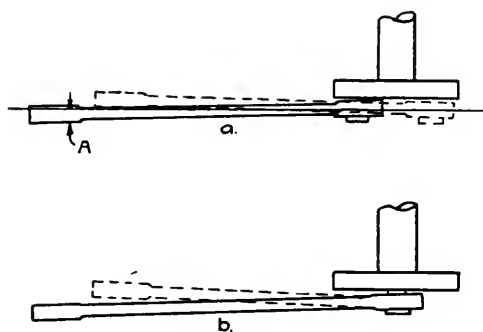
FIG. 11.

parallelism with the crank shaft is illustrated, in exaggerated form, in Fig. 11a. Such a condition will produce overheating and serious strains in the engine when it is running. The trueness of the crankpin in this respect may readily be observed by turning the crankpin with the rod to one of the positions shown, measuring the distance *A*, and then swinging the parts to the other position and repeating the measurement. If the two distances, *A*, *A* agree, the crankpin is in correct alignment but if they do not agree some adjustments must be made either by scraping or by suitable machine work. Conditions vary so greatly that no exact procedure for correcting this type of fault can be prescribed. Since the crankpin may be bent in the direction shown in Fig. 11b the test should also be carried out in the positions shown there.

Another condition that may exist is that the center line of the crankpin brass may not be perpendicular to the center line of the connecting rod. To test for this, connect the rod to the crankpin, bring the bearing brass snugly against the inner shoulder of the crankpin, and note the distance *A* as in Fig. 11a. Then disconnect the rod from the pin, turn it over half way and repeat the measurement. If the relation between the cylinder center line and the line on the rod is the same as in the first case the crankpin brass is in correct alignment.

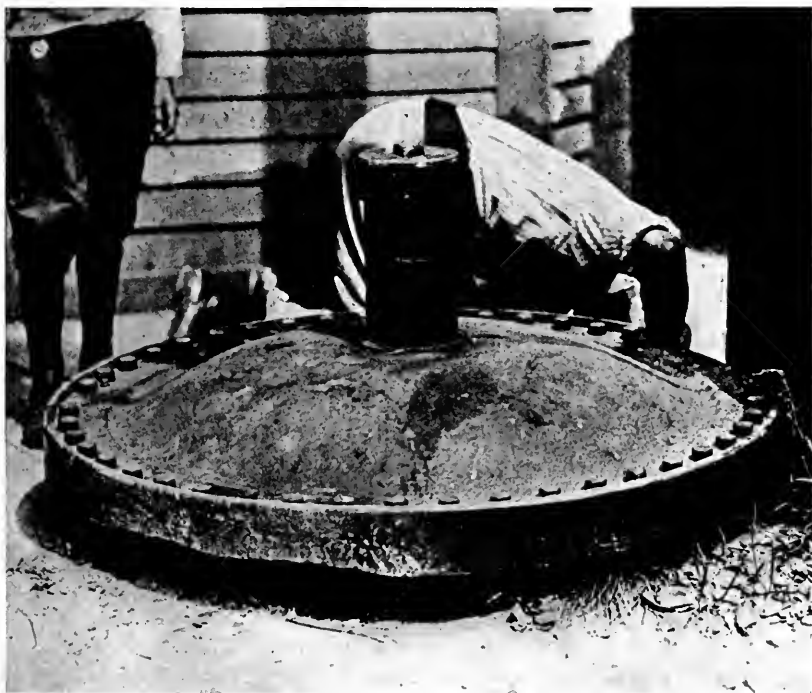
HEAD OF EXPLODED LAUNDRY MANGLE.

The guests of the Hotel Pemberton and the residents of Hull, Mass., had an element of terror injected into their peaceful summer life on August 11th by the explosion of a mangle in the laundry of the hotel. A newspaper account in *The Boston Post* for August 12th stated that the explosion wrecked the laundry, tore an eight foot hole in the hotel wall as great pieces of the mangle, weighing hundreds of pounds, were hurled through it, and scattered debris all about the New Haven Railroad station and the Nantasket Beach Steamboat pier. Ten persons were injured in the accident, eight of them being

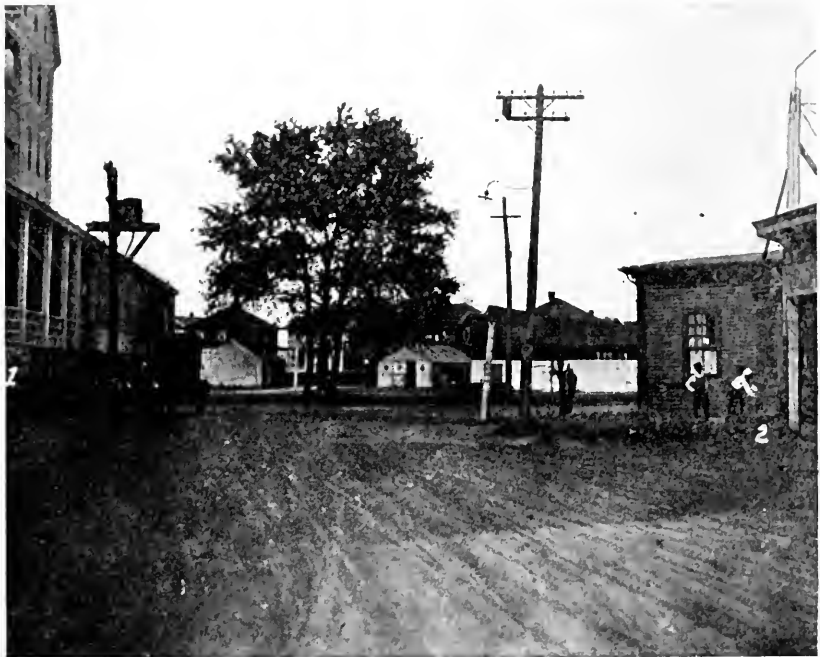
SHOWING FLIGHT OF THE MANGLE HEAD.

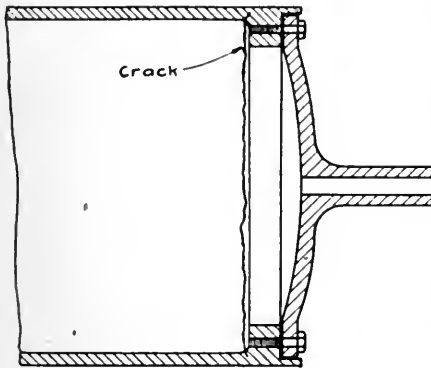
FIG. 1.

the escape of steam it would appear that it materially weakened the shell. Examination of the broken parts showed that the casting had been cracked for some time at the base of the flange, as shown in Fig. 1, this defect extending around the circumference meeting the

welded portion at both ends, and varying in depth from one eighth to three eighths of an inch from the inside surface of the shell. The extent of this crack at the point where the leak developed could not be determined because the welding had destroyed all traces other than those mentioned above. The welded portion extended for about twenty-five inches around the circumference and was about five inches wide but its holding power was probably slight since a large portion of it appeared defective. At the break, the larger part of the weld had the appearance of slag which indicated that the metal had not fused at all, excepting on the outside surface. While no doubt the crack which already existed in the mangle cylinder would, in time, have caused a failure, it is, on the other hand, very likely that the welding hastened the end.

It was said that a few days prior to the explosion steam was seen escaping through a crack in the cast iron shell close to one of the heads of the mangle. To stop this leak, autogenous welding was resorted to and while this method of repair temporarily stopped

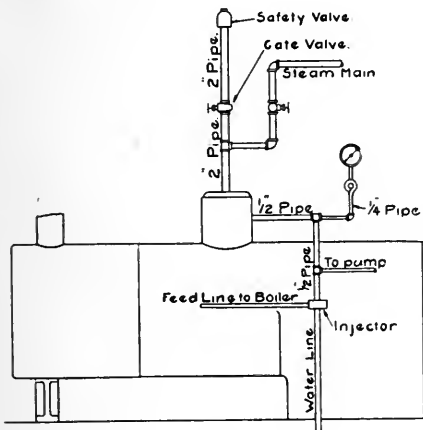
FIG. 2.

"A sketch of the boiler with its improper pipe connections is given in Fig. 2. In addition to what is shown there I might mention that the blow off line had been piped outside the building where a trap had been formed so that any water accumulating in it would freeze very readily. A man, in blowing down the boiler, would have been placed in a very dangerous position.

"I stepped outside to look up at the valve which was about twelve feet above the boiler and while looking at it the blowing stopped. A few minutes later I walked in and looked at the pressure gauge. It showed 140 pounds. I immediately started an investigation to determine the reason for the safety valve remaining closed with this pressure behind it and, when I climbed up on the boiler, I soon discovered the cause. There I found a gate valve, closed tight, in the line leading to the safety valve. Apparently the engineer had closed

it when I stepped outside for just then I saw him come around to the front of the boiler, glance at the pressure gauge, and then rush up the ladder to open the gate valve. This I cautioned him to do slowly as a sudden release of the pressure on the boiler might have caused an explosion. As soon as a few turns had been given the gate valve to open it the safety valve began to blow and continued to do so until the pressure was reduced to 100 pounds.

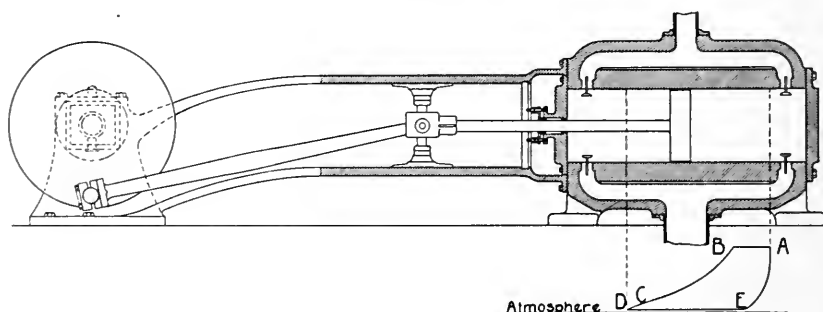
FIG. 1.

The reciprocating steam engine may be illustrated diagrammatically as in Fig. 1. At each end of the cylinder are shown two valves, those at the top being for admission of steam and those at the bottom being for the exit or the exhaust of the used steam. Considering the head end (the right hand end in this sketch) of the cylinder, we have first that the admission valve, operated by the valve gear which is driven by the engine, is opened and steam practically at

boiler pressure is admitted. The pressure thus created in the cylinder drives the piston forward, thereby turning the crank shaft. When the piston has moved about one-quarter of its stroke the admission valve closes. The steam that is thereby entrapped in the cylinder is at high pressure and the piston, therefore, continues its motion, but as soon as it does so the volume occupied by the steam increases and the pressure begins to fall. Nevertheless, the pressure continues for some time to be sufficient to drive the piston forward. Under normal operating conditions the engine is so designed that as soon as the pressure of this steam falls to a point such that it can no longer be effective in driving the piston the exhaust valve at the head end is opened and the steam permitted to escape. This action, known as "release," may be considered to take place when the piston has completed about nine-tenths of its forward stroke. The exhaust valve remains open and the steam escapes from the cylinder during the remaining one-tenth of the forward stroke, and through the greater part of the return stroke when the piston goes from the crank end to the head end of the cylinder. The exhaust valve closes when the piston has completed about eight-tenths of the return stroke, and the steam remaining in the cylinder is then compressed thereby reducing the volume and at the same time increasing the pressure. This action of compressing the steam assists in giving smooth operation over the end or dead points when the reciprocating parts change their direction of motion. For this reason, the term "cushioning" is often applied to this action of using some of the exhaust steam as a buffer to take the shock out of the end of the stroke. At or near the end of the stroke the steam admission valve opens again and the whole cycle of events is repeated. With a double acting engine there is also a similar action taking place in the crank end of the cylinder.

In Fig. 1 we had the engine exhausting to the atmosphere which is a space of constant pressure. In the present arrangement we shall substitute a condenser which, being constantly cooled by water at a uniform temperature, reduces the exhaust steam to water and provides a space of constant pressure.

The temperature of the cooling water will determine what this pressure will be. Furthermore, in Fig. 1 we had release taking place slightly before the end of the stroke of the piston. In this case, as will be noticed, we do not open the exhaust valve until the completion of the forward piston stroke. The pressure in the cylinder then drops approximately to that in the condenser and, with the return stroke of the piston, we get the line CDE. This line also differs from the corresponding line of Fig. 1 in that we have continued it back to the end of the return stroke.

In this we have differed a little from the actual engine of Fig. 1 in which some of the steam was retained in the cylinder for the cushioning effect. The *weight* of steam so retained, however, is comparatively small and the difference between the real and this imaginary engine is without relative importance.

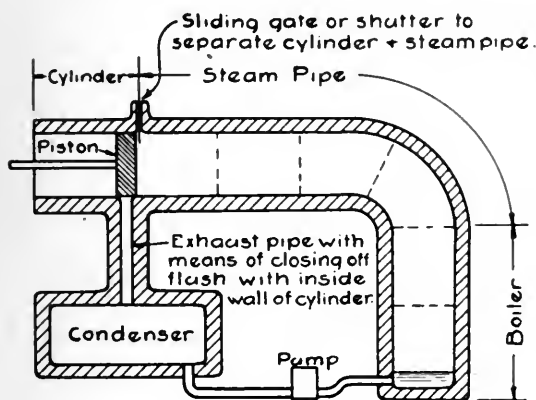
FIG. 2.

Let us suppose that we have a specially constructed boiler, engine and connecting steam pipe, all built with the same cross section as shown in Fig. 2 on the opposite page. Suppose further that steam has been generated at some given pressure, until all the space is filled between the surface of the water in the boiler and piston in the cylinder. We might consider that the space mentioned is filled with several unit volumes of steam in contact with each other, as indicated by the dotted lines in the boiler and steam pipe, and of such a size that each weighs one pound. Now we can cause the piston to move and to increase the volume between it and the position shown in the sketch by pro-

ducing or generating another unit volume of steam at the surface of the water in the boiler. To do this, heat, of course, is required.

The turbine differs from the reciprocating engine in that the flow is continuous in the turbine and is intermittent in the engine. In the imaginary engine of Fig. 2 it was proper for us to isolate a unit volume of steam in the cylinder by the closing of the sliding gate because such action is exactly similar to the operation of the real engine. With the turbine, however, we cannot isolate a unit volume. Nevertheless, we can confine our consideration of the pressure and volume changes to one unit, bearing in mind that every unit that has preceded and everyone that follows after is acting in the same way.

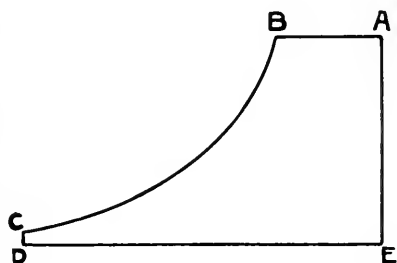
FIG. 3.

By means of the pump shown in Fig. 3 the condensed steam may be taken from the condenser and returned to the boiler. In so doing it should be noted that the volume changes but very little, while its pressure is raised from that in the condenser to that in the boiler.

turbine, yet the volume and pressure changes which a pound of water or steam undergoes in the turbine are exactly the same as in the engine. This we will attempt to explain and in doing so, we will use an imaginary arrangement similar to that of Fig. 3 but adapted for a steam turbine.

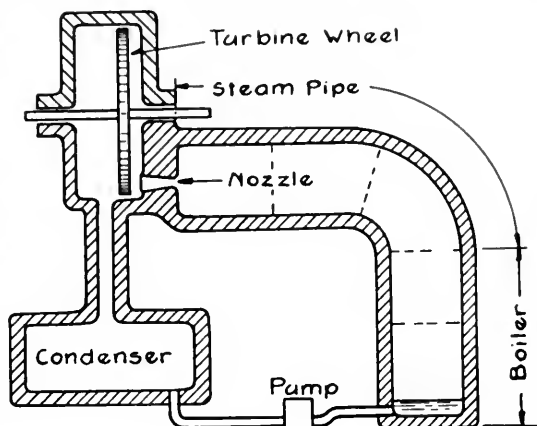
FIG. 4.

This sketch, Fig. 4, shows, diagrammatically, a boiler with a steam pipe of the same cross section leading to the nozzle of the turbine. If we are to maintain constant pressure in the boiler while a pound of steam flows from the pipe into the nozzle of the turbine, we must change one pound of the water in the boiler into one pound of steam, thereby pushing along the successive unit volumes of steam and in turn causing the flow of one unit into the nozzle. Considering the chart shown in Fig. 5 as representing the pressure and volume changes taking place in one pound of steam or water the line AB will indicate this first action of changing from water into steam at constant pressure.

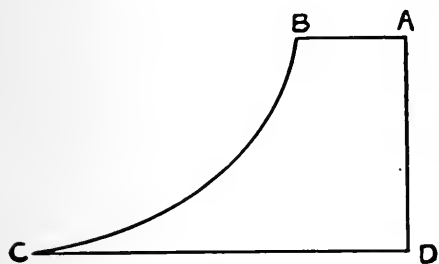
FIG. 5.

volume increasing and the pressure falling, so that at the mouth of the nozzle the pressure has fallen to its lowest value. Such a change can be represented on our chart by the line BC. It will be noted in this chart for a turbine that this expansion line continues until it meets the exhaust line CD in a point and is not chopped off by a vertical line, such as CD in Fig. 3. It will be remembered that in the steam engine the expansion was stopped when the *pressure* had fallen so low that it would no longer be effective in driving the piston. In the turbine the continuation of the expansion beyond the point D of Fig. 3 results in increased *velocity* to the steam and thereby enables the turbine to make use of this "tail end" of the diagram.

Since there is no further change in pressure and volume while the steam is acting on the blades of the turbine, it is impossible to chart this part of the steam flow. After the expansion in the nozzle and when the steam has been brought to the pressure and volume conditions represented by the point C in Fig. 5, the next change to take place, from our viewpoint, is the condensation of the steam in the condenser. This action is exactly the same as in the case of the steam engine and can be represented by the line CD in Fig. 5. So also, the return of the condensed steam to the boiler by the feed pump can be indicated by the vertical line DA.

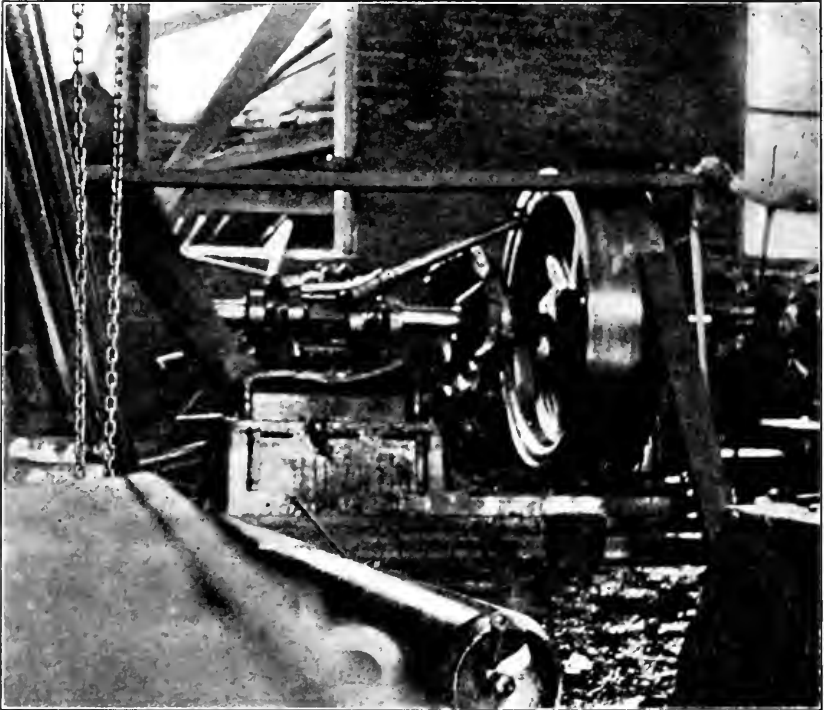
WRECKED AMMONIA COMPRESSOR.

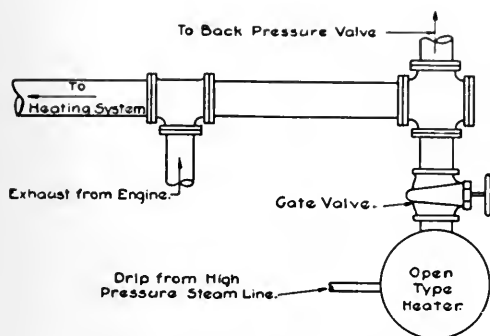
PIPE CONNECTIONS TO HEATER.

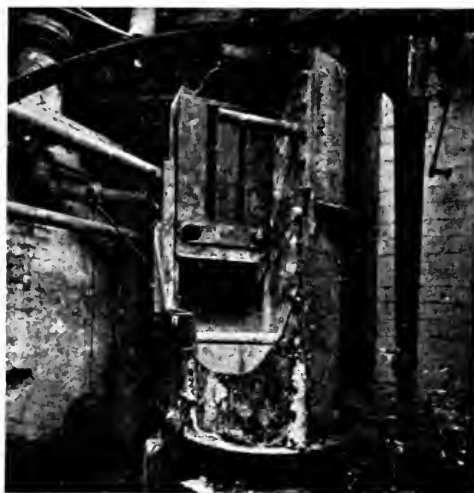
WRECK OF AN OPEN FEED WATER HEATER.
